N5172B-09

Information Only Service Note

N5172B X-Series EXG Vector Signal Generator

The Problem – Self-test #104 failure if replacement A3 RF Assembly, N5180-60279 with Hardware ID 0009 is not upgraded to the minimum FW B.01.96.

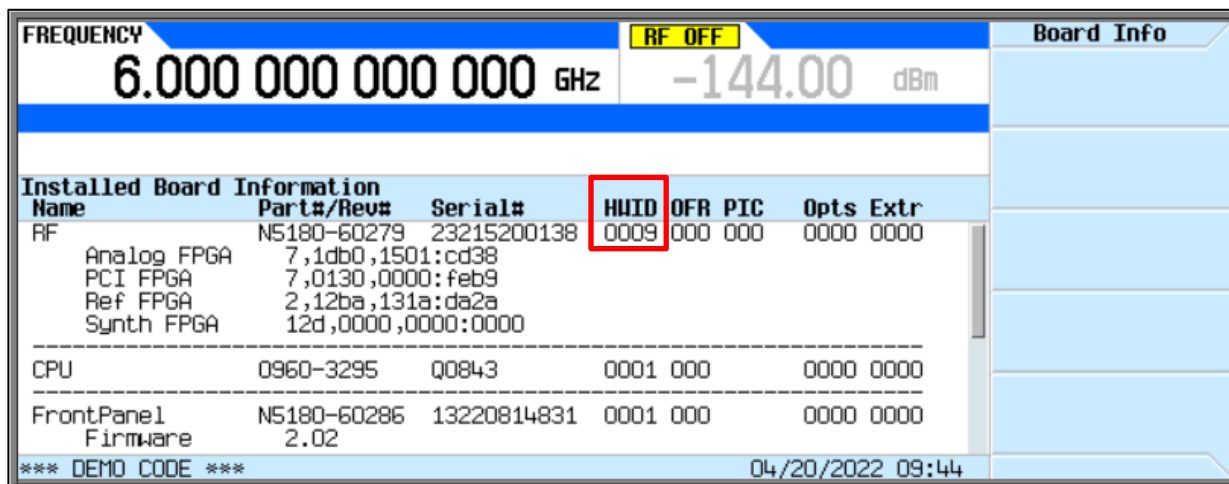
Figure 2 - Installed Board Information Screen

First, check that the RF assembly is with hardware ID 0009. This can be found on the Utility, Instrument Info, Installed Board Info screen of the instrument, as shown in Figure 2.
