N5172B-10B

Information Only Service Note

N5172B X-Series EXG Vector Signal Generator

The Problem - Improper handling during removal and installing during A3 RF assembly boards potential for Heater and Unlock errors

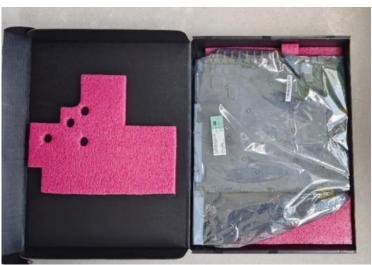
Figure 3

Below figures 3 and 4 shows the correct and incorrect method to remove the A3 RF assembly board from the carton box.

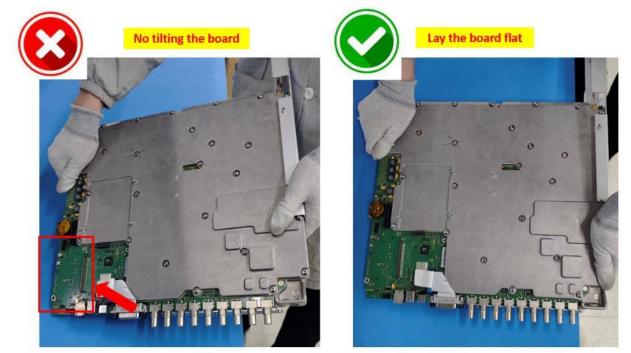
Figure 5

Avoid tilting the board where components touches the workbench. This would give pressure on the PCA and potentially can damaged the PCA as well as the components in the area. Always lay the board flat on the workbench. Refer to Figure 5.

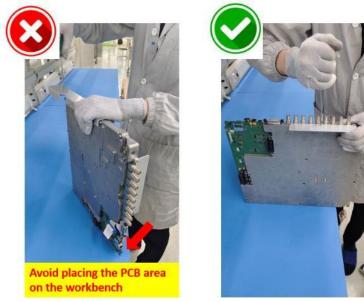
Figure 6 shows the correct and incorrect method of holding the board while removing and fixing the fixture.

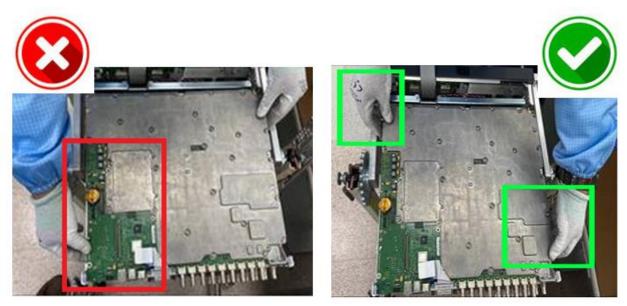
Figure 8 shows the correct and incorrect method of holding the board while removing and installing the board to the instrument.

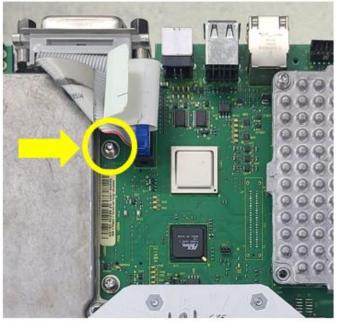
Figure 9

Another precaution is when removing and reinstalling back the screw (refer to Figure 9), it is not necessary to remove the ribbon cable to avoid re-attaching the ribbon cable back.

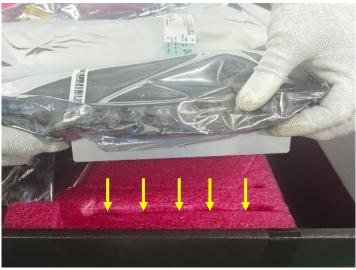
Figure 10

Refer to Figure 5 and 6 to re-install the bracket. Placed the board back into the ESD bag and return it back into the carton box. Referring to Figure 10, slot the bracket into the groove of the foam board. This is to ensure the board will be secure during shipment.
