N5173B-09

# Information Only Service Note

## N5173B X-Series EXG µWave Signal Generator

The Problem – Self-test #104 failure if replacing either the A3 RF Assembly with Hardware ID 000B or the A7 Micro-deck containing A7A1 ALC control board with hardware ID 0002 is not upgraded to the minimum FW B.01.96.

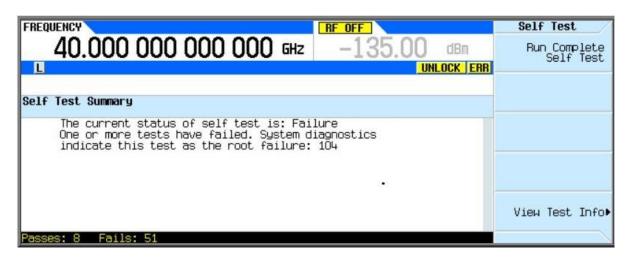
The A3 RF assemblies and A7A1 ALC control board on the A7 micro-deck were enhanced to support a new 12bit ADC for assurance of supply (AOS). Replacement of either the A3 RF Assembly, N5180-60173 with Hardware ID 000B or the A7 Micro-deck containing A7A1 ALC control board, N5180-60172 with Hardware ID 0002 will require minimum FW B.01.96 for it to operate properly. Multiple self-test failures can be observed after completing the self- test, as shown in Figure 1.

Figure 1 - Multiple self-test failures

Upgrade the instrument firmware to B.01.96. Go to <a href="http://www.keysight.com/find/exg\_firmware">http://www.keysight.com/find/exg\_firmware</a> to download the instrument firmware.

Once the firmware successfully upgraded, verify that the self-test is passing on the instrument.

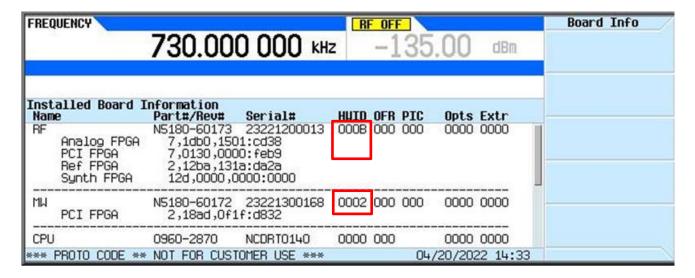
First, check that the hardware ID for the replaced assembly. This can be found on the **Utility**, **Instrument Info**, **Installed Board Info** screen of the instrument, as shown in Figure 2.

Figure 2 - Installed Board Information Screen

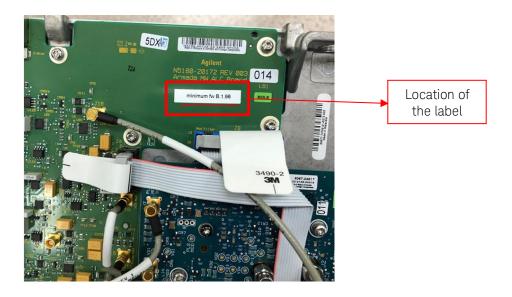
On the micro-deck, a label "minimum FW B.1.96" will be pasted on the ALC control board as shown in Figure 4.

Figure 4 – Location of label on the ALC control board
