Information Only Service Note

N5173B X-Series EXG μ Wave Signal Generator

The Problem - Improper handling during removal and installing during A3 RF assembly boards potential for Heater and Unlock errors

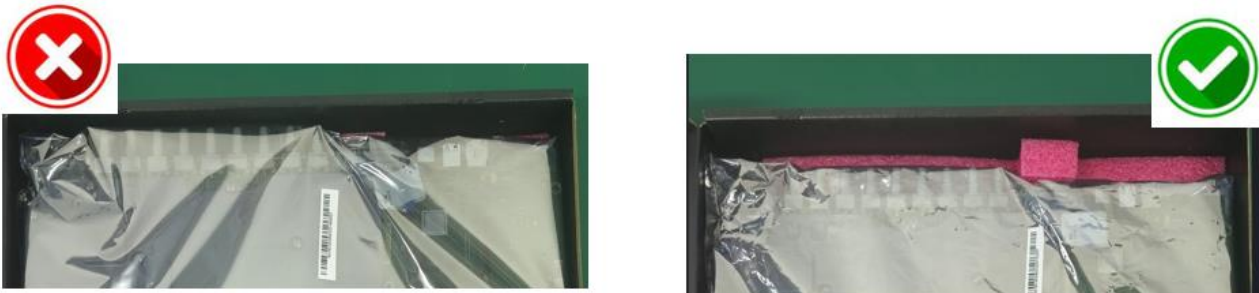
Figure 11 shows the shipment condition of the board if the bracket is not placed properly in the groove. The ESD packaging when placed properly will be securely inside the red foam. This will prevent the board damaged during shipping.
