N5181B-06

Information Only Service Note

N5181B X-Series MXG Analog Signal Generator

The Problem – Self-test #104 failure if replacement A3 RF Assembly N5180-60296 with Hardware ID 0008 is not upgraded to the minimum FW B.01.96.

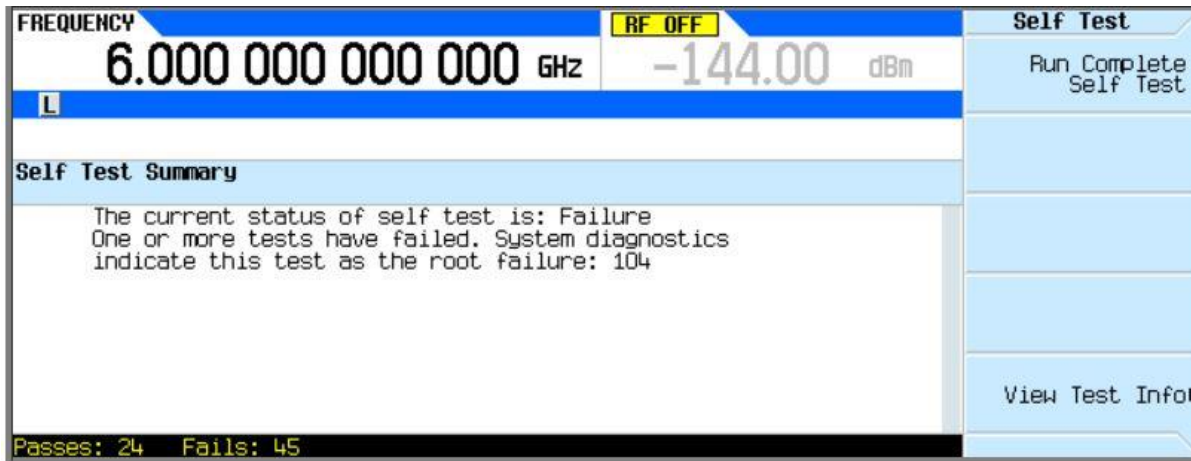
The A3 RF assemblies were enhanced to support a new 12bit ADC for assurance of supply (AOS). Replacement of the A3 RF Assembly, N5180-60296 with Hardware ID 0008 will require minimum FW B.01.96 for it to operate properly. Multiple self-test failures can be observed after completing the self-test, as shown in Figure 1.

Figure 1 - Multiple self-test failures

Upgrade the instrument firmware to B.01.96. Go to http://www.keysight.com/find/mxg_firmware to download the instrument firmware.

Once the firmware successfully upgraded, verify that the self-test is passing on the instrument.

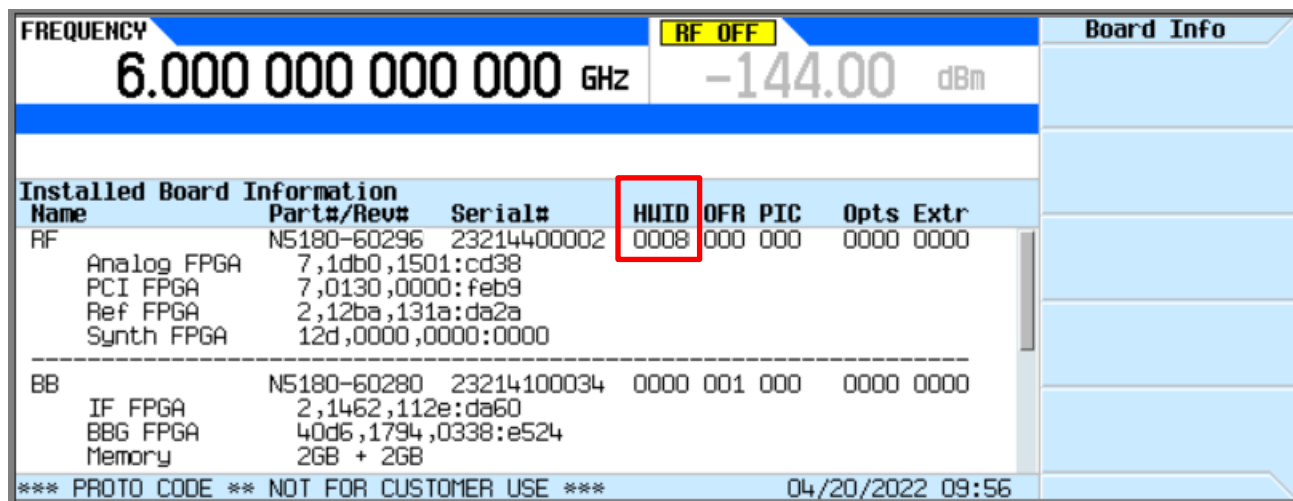
First, check that the RF assembly is with hardware ID 0008. This can be found on the Utility, Instrument Info, Installed Board Info screen of the instrument, as shown in Figure 2.

Figure 2 - Installed Board Information Screen

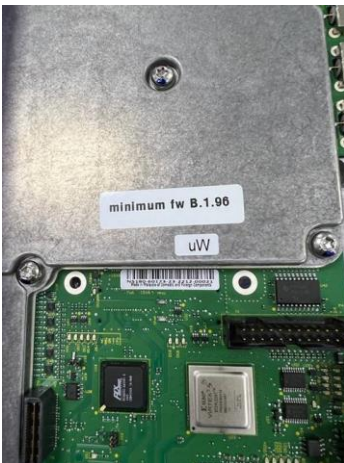
Factory has also made an identification, where a label “minimum FW B.1.96” is pasted on the shield, as shown in Figure 3.

Figure 3 – Location of label on the RF assembly
