Information Only Service Note

N5181B X-Series MXG Analog Signal Generator

The Problem - Improper handling during removal and installing during A3 RF assembly boards potential for Heater and Unlock errors

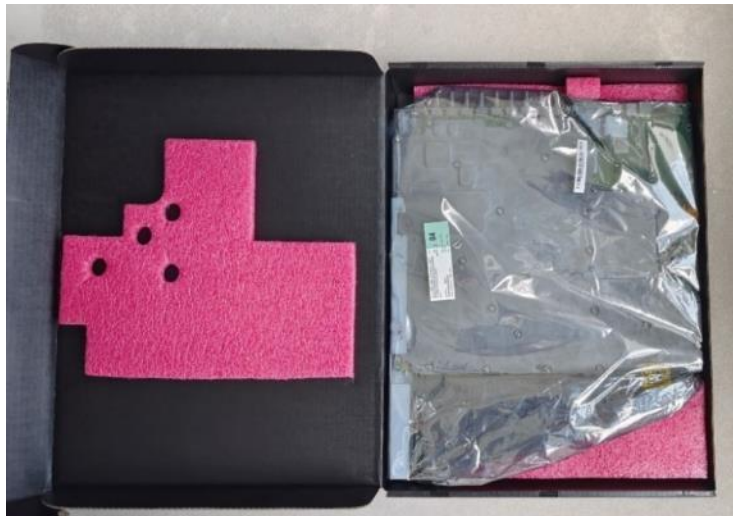
Figure 3

Below figures 3 and 4 shows the correct and incorrect method to remove the A3 RF assembly board from the carton box.

This Service Note is to emphasize on the proper handling of the A3 RF Assembly board, from removal of the assembly from the carton box, handling on the workbench to removal from instrument and the replacement procedure. **The A3 RF Assembly DEF failure due to Heater issue is at 15%. The procedure mentioned below need to be adhere also when returning the DEF since the DEF will be repaired and stock to SLSC as refurbishment.**

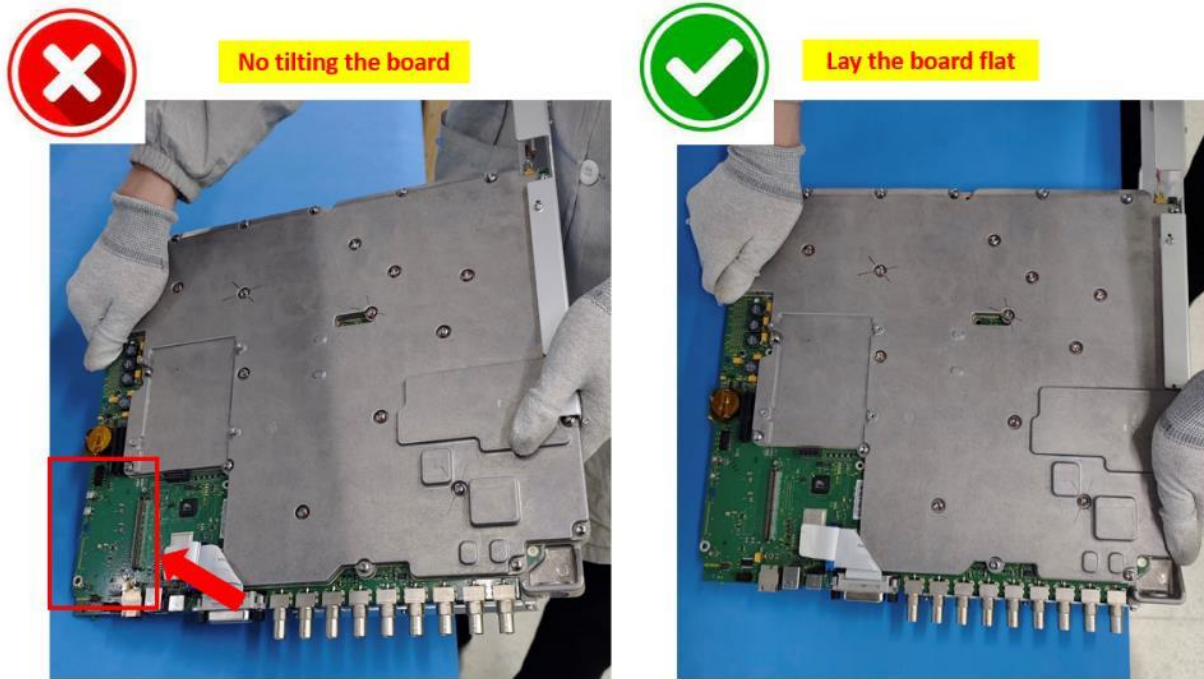
Figure 5

Avoid tilting the board where components touches the workbench. This would give pressure on the PCA and potentially can damaged the PCA as well as the components in the area. Always lay the board flat on the workbench. Refer to Figure 5.

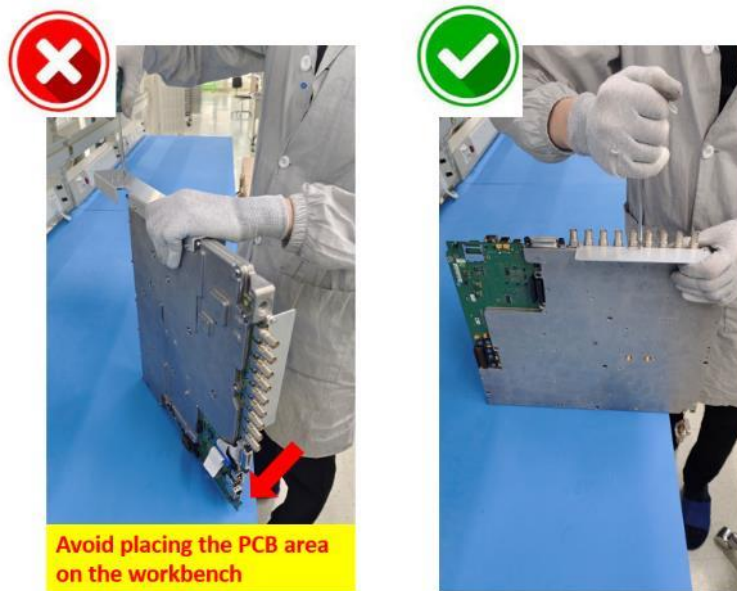
Figure 6 shows the correct and incorrect method of holding the board while removing and fixing the fixture.

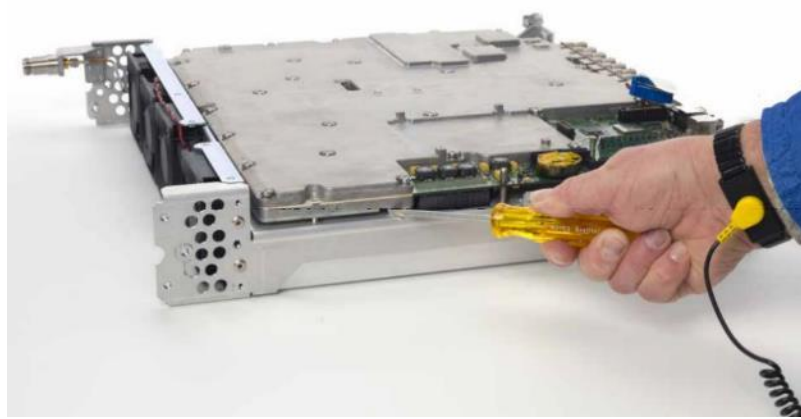
Figure 7

Pry slots are provided on both sides of the A3 RF assembly to aid in removing of the board. Use a flat head (a wedge-shaped flat tip) screwdriver to loosen the board from the chassis as shown in Figure 7.

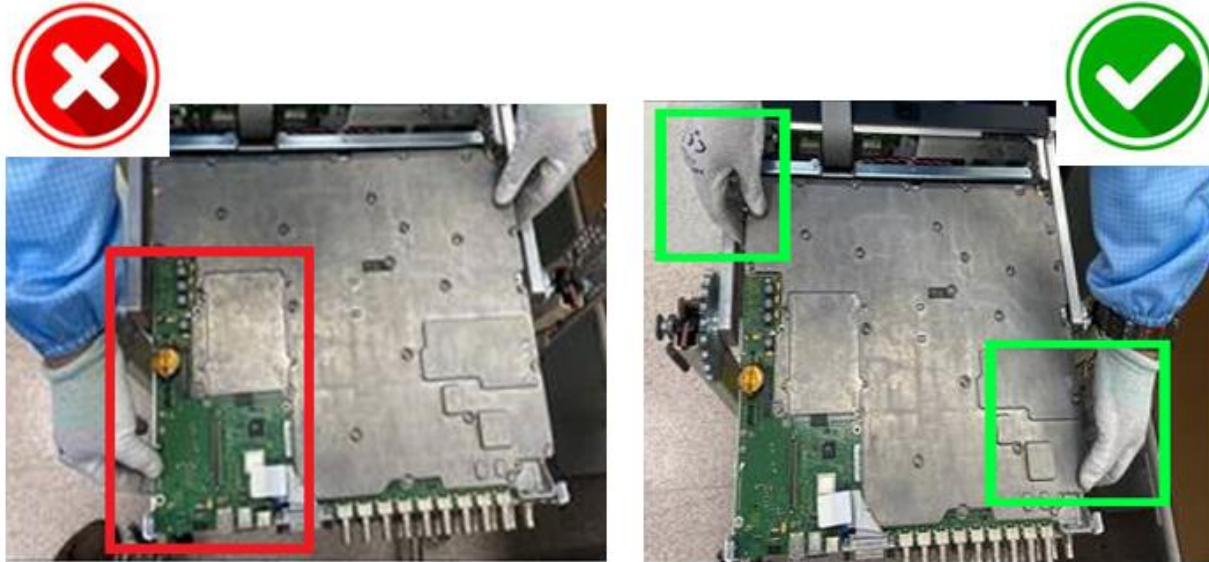
Figure 8 shows the correct and incorrect method of holding the board while removing and installing the board to the instrument.

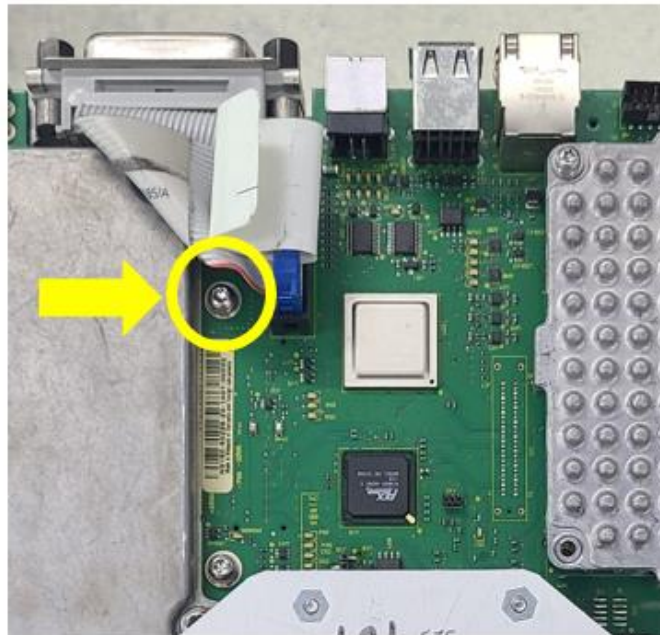
Figure 9

Another precaution is when removing and reinstalling back the screw (refer to Figure 9), it is not necessary to remove the ribbon cable to avoid re-attaching the ribbon cable back.

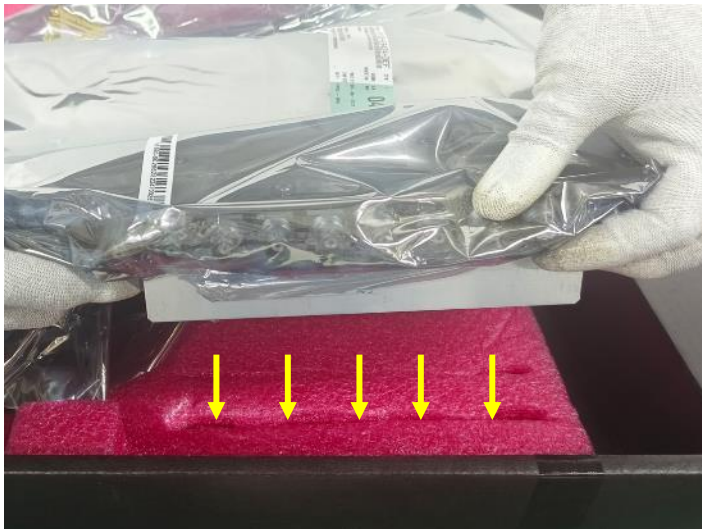
Figure 10

Refer to Figure 5 and 6 to re-install the bracket. Placed the board back into the ESD bag and return it back into the carton box. Referring to Figure 10, slot the bracket into the groove of the foam board. This is to ensure the board will be secure during shipment.

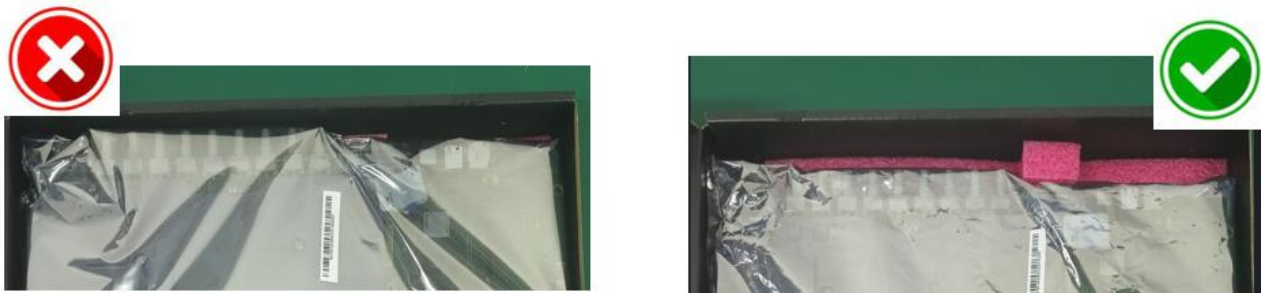
Figure 11 shows the shipment condition of the board if the bracket is not placed properly in the groove. The ESD packaging when placed properly will be securely inside the red foam. This will prevent the board damaged during shipping.
