N5182B-12

Information Only Service Note

N5182B X-Series MXG Vector Signal Generator

The Problem - Self-test #104 failure if replacement A3 RF Assembly N5180-60296 with Hardware ID 0008 is not upgraded to the minimum FW B.01.96.

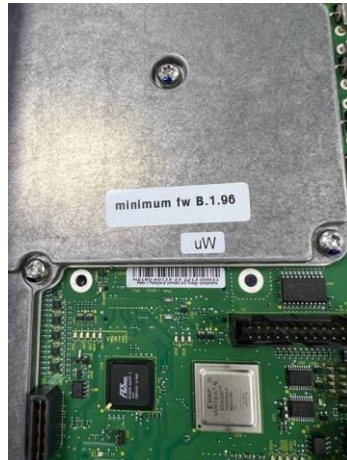
Figure 3 – Location of label on the RF assembly

Factory has also made an identification, where a label “minimum FW B.1.96” is pasted on the shield, as shown in Figure 3.
