Information Only Service Note

N5182B X-Series MXG Vector Signal Generator

The Problem - Improper handling during removal and installing during A3 RF assembly boards potential for Heater and Unlock errors

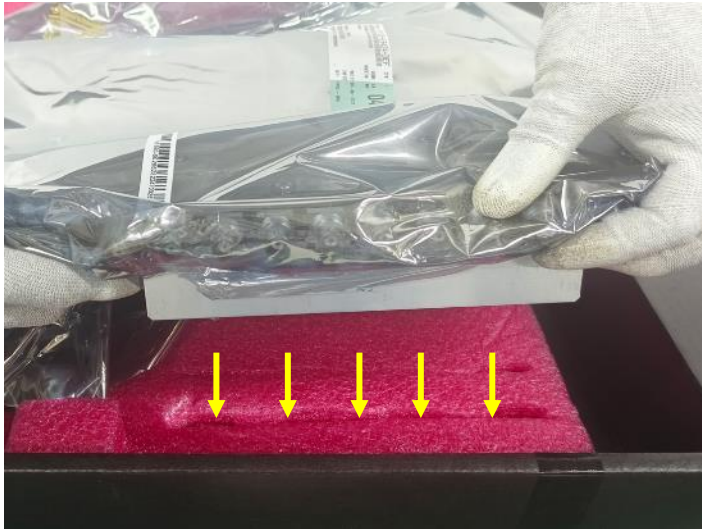
Figure 10

Refer to Figure 5 and 6 to re-install the bracket. Placed the board back into the ESD bag and return it back into the carton box. Referring to Figure 10, slot the bracket into the groove of the foam board. This is to ensure the board will be secure during shipment.

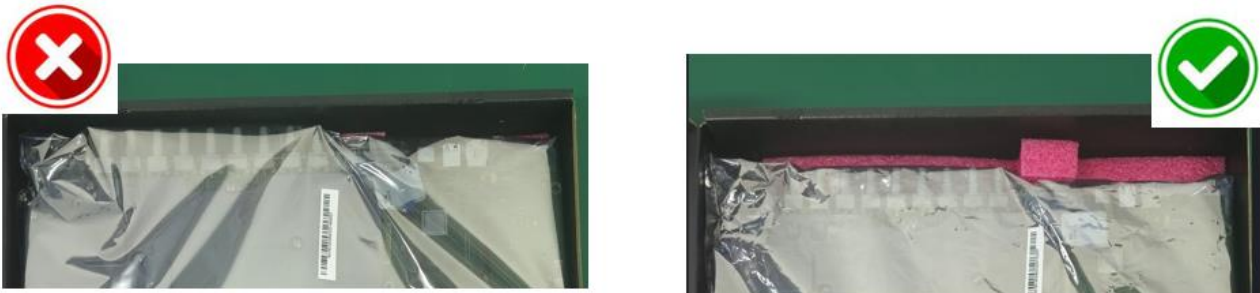
Figure 11 shows the shipment condition of the board if the bracket is not placed properly in the groove. The ESD packaging when placed properly will be securely inside the red foam. This will prevent the board damaged during shipping.
