N5183B-07A

Information Only Service Note

N5183B X-Series MXG μ Wave Analog Signal Generator

The Problem – Potential for Damage Caused by Safety Testing

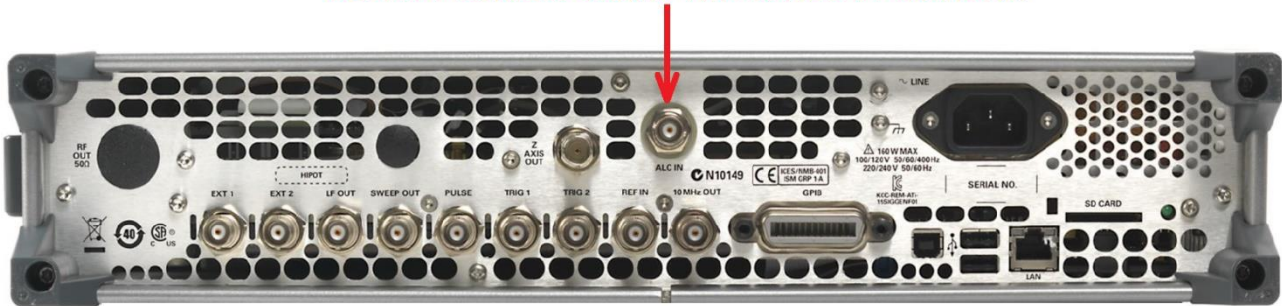
It has come to our attention that instruments have been damaged when performing incoming and outgoing safety testing on these instruments. These safety testers require that a ground wire from the tester be connected to the instrument chassis. This connection is often made to the outer conductor of one of the rear panel BNC connectors. The problem occurs when the ground wire is connected to the ALC IN rear panel BNC connector outer conductor when the test is run. Connecting the ground to this point is a problem because the ALC IN connector outer conductor is not connected to the chassis of the instrument. It is isolated from the chassis ground with a plastic washer. Not only is this an invalid point to connect the ground wire to for this test, it also sends the voltage used for the test directly into the sensitive ALC input circuitry.

DO NOT Connect Ground Wire to ALC IN Connector

The typical failure symptoms of an instrument that has been exposed to this is the failure of Self Tests 407, 1107, 1108, 1112 (some or all of these). The parts that will be damaged are on the A7A1 Microwave ALC Control board, so the power level accuracy test will most likely fail as well.

Do not connect the safety tester ground wire to the ALC IN connector shield.

It is also recommended that a static safe protective cap be put on the ALC IN connector before it is given to your logistics team so that nobody will be able to easily connect the ground wire to it when they perform a safety test. This will also help to protect it if it goes through an incoming inspection safety test once it has reached its destination.
