N5183B-10

# Information Only Service Note

## N5183B X-Series MXG $\mu$ Wave Signal Generator

**The Problem: Problem** – Self-test #104 failure if replacing either the A3 RF Assembly with Hardware ID 000A or the A7 Micro-deck containing A7A1 ALC control board with hardware ID 0002 is not upgraded to the minimum FW B.01.96.

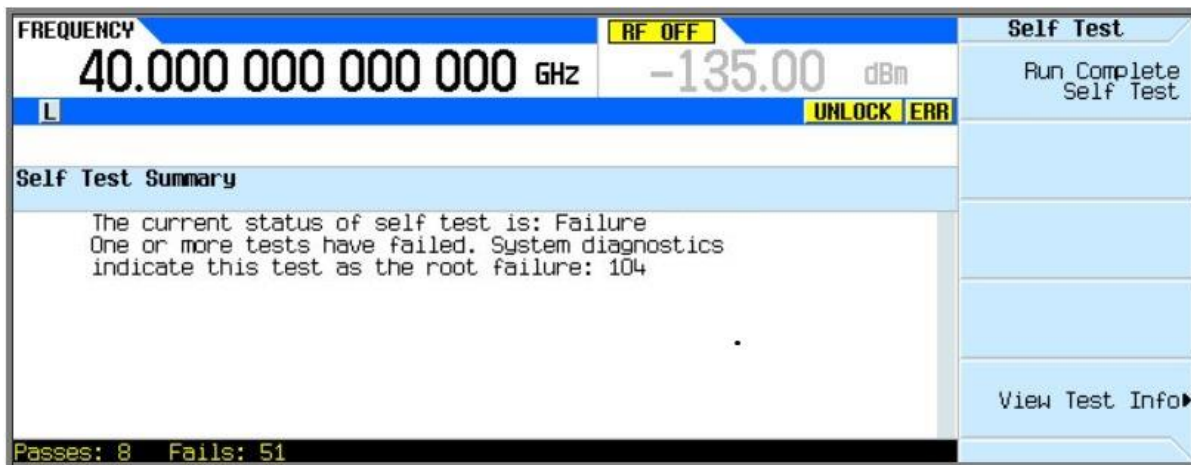
The A3 RF assemblies and A7A1 ALC control board on the A7 micro-deck were enhanced to support a new 12bit ADC for assurance of supply (AOS). Replacement of either the A3 RF Assembly, N5180-60173 with Hardware ID 000B or the A7 Micro-deck containing A7A1 ALC control board, N5180-60172 with Hardware ID 0002 will require minimum FW B.01.96 for it to operate properly. Multiple self-test failures can be observed after completing the self- test, as shown in Figure 1.

Figure 1 - Multiple self-test failures

Upgrade the instrument firmware to B.01.96. Go to [http://www.keysight.com/find/mxg\\_firmware](http://www.keysight.com/find/mxg_firmware) to download the instrument firmware.

Once the firmware successfully upgraded, verify that the self-test is passing on the instrument.

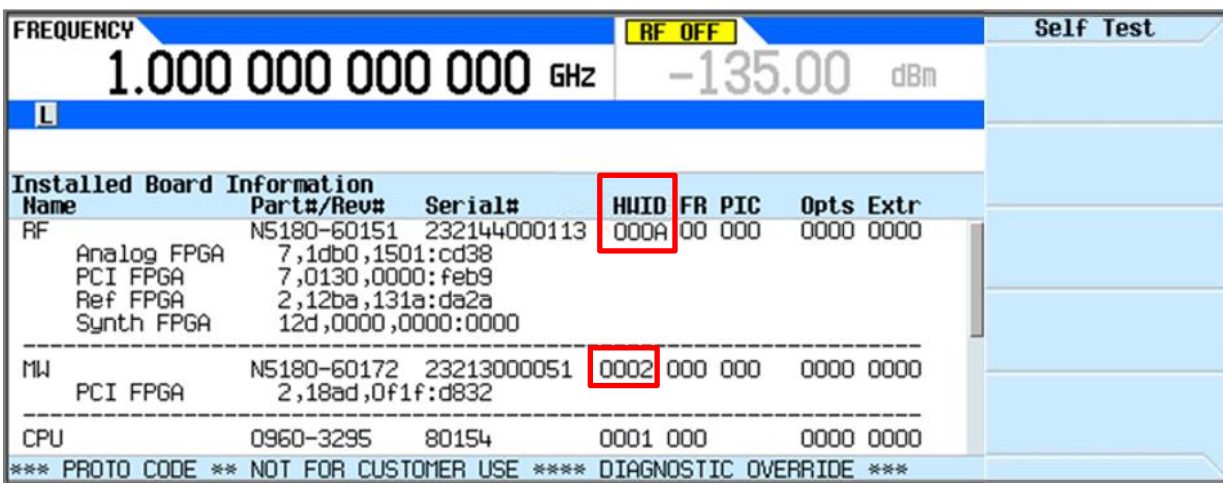
First, check that the hardware ID for the replaced assembly. This can be found on the Utility, Instrument Info, Installed Board Info screen of the instrument, as shown in Figure 2.

Figure 2 - Installed Board Information Screen

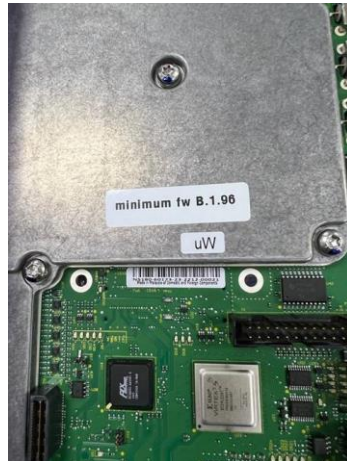
On the RF assembly, a label “minimum FW B.1.96” will be pasted on the shield, as shown in Figure 3.

Figure 3 – Location of label on the RF assembly

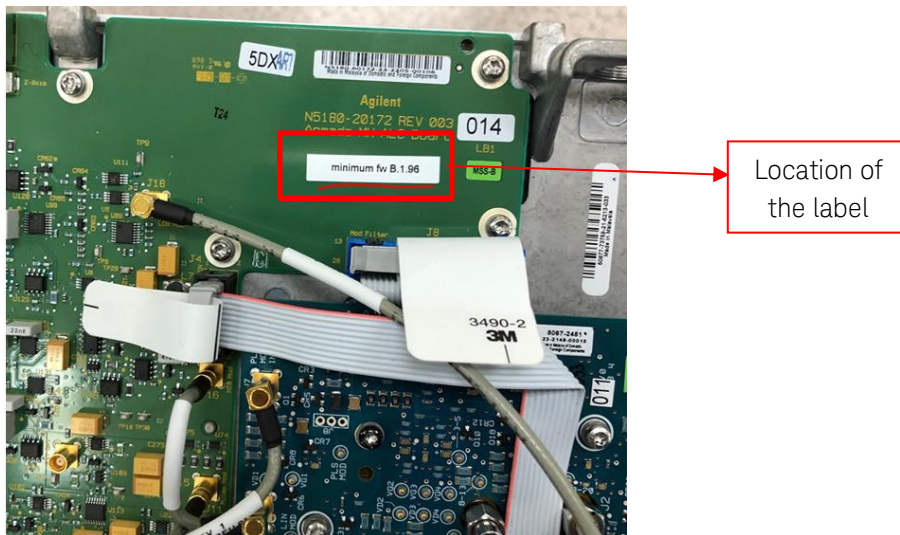
On the micro-deck, a label “minimum FW B.1.96” will be pasted on the ALC control board as shown in Figure 4.

Figure 4 – Location of label on the ALC control board
