Information Only Service Note

N5183B X-Series MXG μ Wave Signal Generator

The Problem - Improper handling during removal and installing during A3 RF assembly boards potential for Heater and Unlock errors

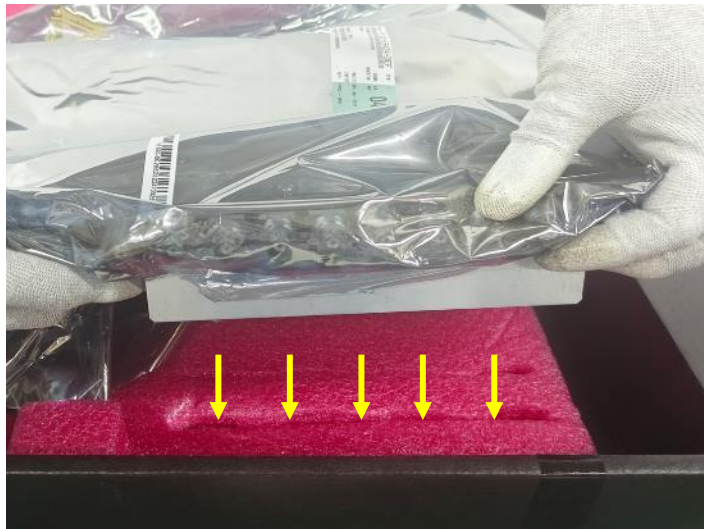
Figure 10

Refer to Figure 5 and 6 to re-install the bracket. Placed the board back into the ESD bag and return it back into the carton box. Referring to Figure 10, slot the bracket into the groove of the foam board. This is to ensure the board will be secure during shipment.
