N6954A-02

Modification Recommended Service Note

N6954A – Advanced Power System, DC Power Supply, 80V, 12.5A, 1000W

The Problem – Charge Present on the AC terminal when unplugging the unit.

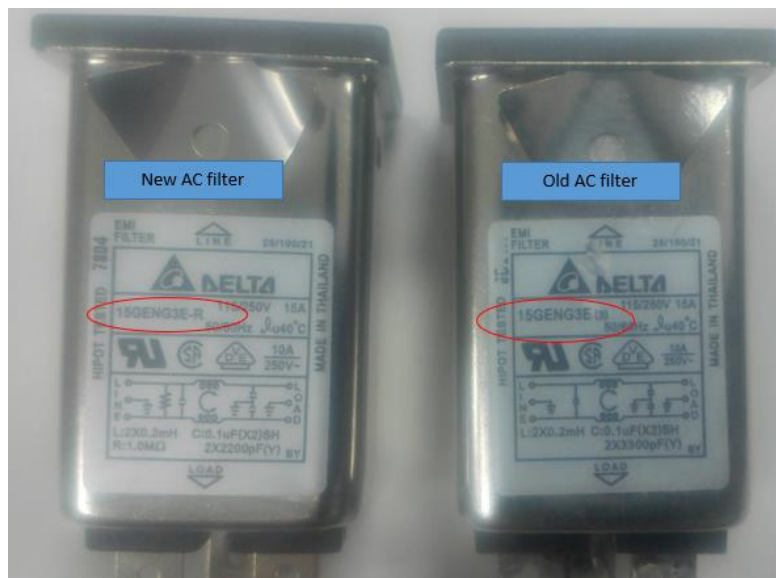
A charge is present on the AC terminal when unplugging the unit and the switch is off. Input capacitor of 0.47pF will store a charge above compliance limit A for normal operating condition at 230Vac input, however non-hazardous since the charge is < compliance limit B for single fault condition. This does not meet the requirements of IEC61010-1.

New AC line filter (5190-4495) with 15GENG3E-R is used to replace the existing AC line filter to optimize the discharge time.
