N8262A-02

Modification Recommended Service Note

N8262A P-Series Modular Power Meter

Intermittent LAN Connectivity

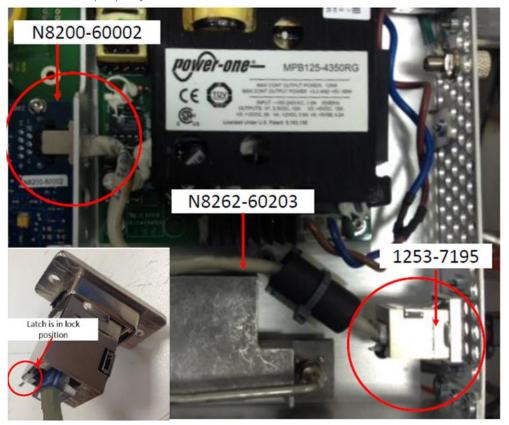
We have received report of some N8262A P-Series Modular Power Meter encountering intermittent connection loss. This has been identified due to the internal LAN cable.

This batch of LAN cable which is made of solid conductor (blue color) is more rigid and resistant to bending. It will be replace with a new enhance stranded conductor LAN cable (grey color) which is more flexible and suitable for bending application.

- d) Assemble new LAN cable (N8262-60203@grey color) to PPMC Assembly (N8200-60002) first and then assemble to rear panel LAN port (1253-7195).
- e) Tie ferrite core with cable tie and route cable as shown below.

f) Ensure LAN cable connection to PPMC Assembly (N8200-60002) and to rear panel LAN port (1253-7195) are latch properly.
