N8757A-07

Information Only Service Note

N8757A DC System Power Supply

The Problem – Units in the above serial number range may encounter missing serial number in WebUI and Keysight Connection Expert.

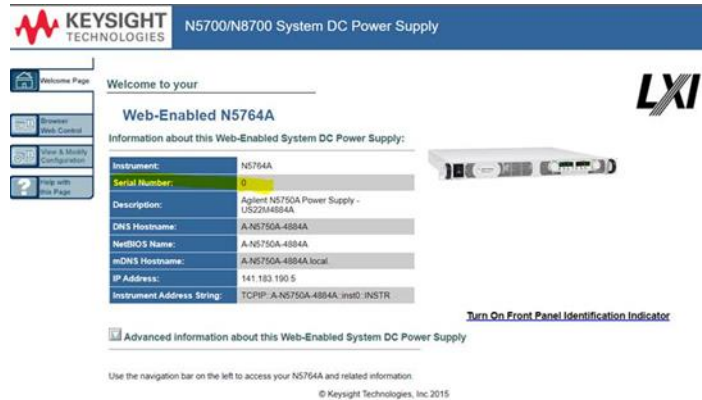
Units in the above serial number range may encounter instrument unsecure store and result in missing serial number. The serial number will show “0” in WebUI and Keysight Connection Expert as shown in Figure 1 and Figure 2 respectively.

Figure 1: Serial number is “0” in WebUI

1. Click on the link: [Secure Store Tool](#) to download the .exe file.
2. Run the “SecureStoreInitialization” fix tool.
3. Follow the instructions stated in the program.
4. The program will run for approx. 45 seconds.
5. Reboot your instrument after the process has completed.
6. Send “SYST:ERR?” to verify that “no errors” are reported.
7. Make sure WebUI and Keysight Connection Expert are showing the serial number.

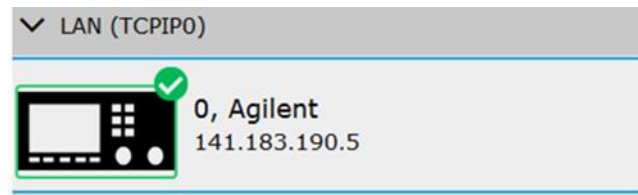
Figure 2: Serial number is “0” in Keysight Connection Expert
