N8920A-01

Modification Recommended Service Note

N8920A - Autoranging System DC Power Supply, 80V, 170A, 5000W, 208 VAC

Serial Numbers: DE14290000 - DE15369999 without manufacturing ID Version "B"

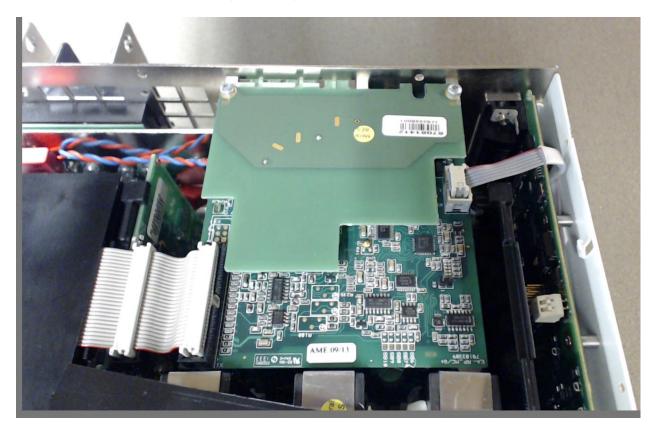
- 1) Remove acMains cable from power source.
- 2) Wait 5 minutes
- 3) Remove top cover from instrument.
- 4) In the 5kW units (viewed from the front of the unit), a small SMT assembly located at the right-rear of instrument will be readily visible (see below):

Removal of two (2) surface mount resistors, R93 and R94, will correct this problem:

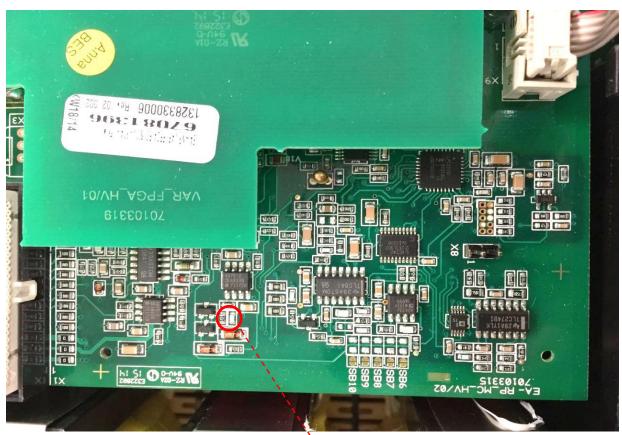
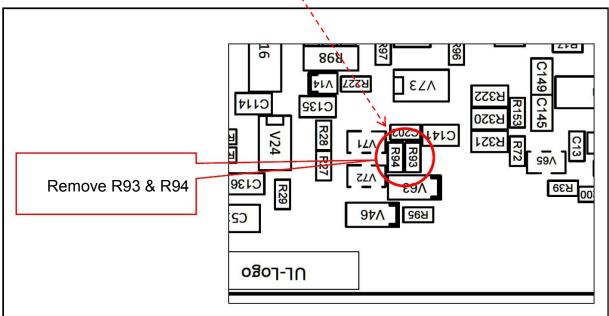
5) SMT resistors R93/94 are located in red circle shown below:

6) After removal of R93 & R94, re-install all covers. Instrument does NOT require recalibration after the removal of R93 & R94.
