Modification Recommended Service Note

N8924A - Autoranging System DC Power Supply, 750V, 20A, 5000W, 208 VAC

Serial Numbers: DE14290000 - DE15369999 without manufacturing ID Version "B"

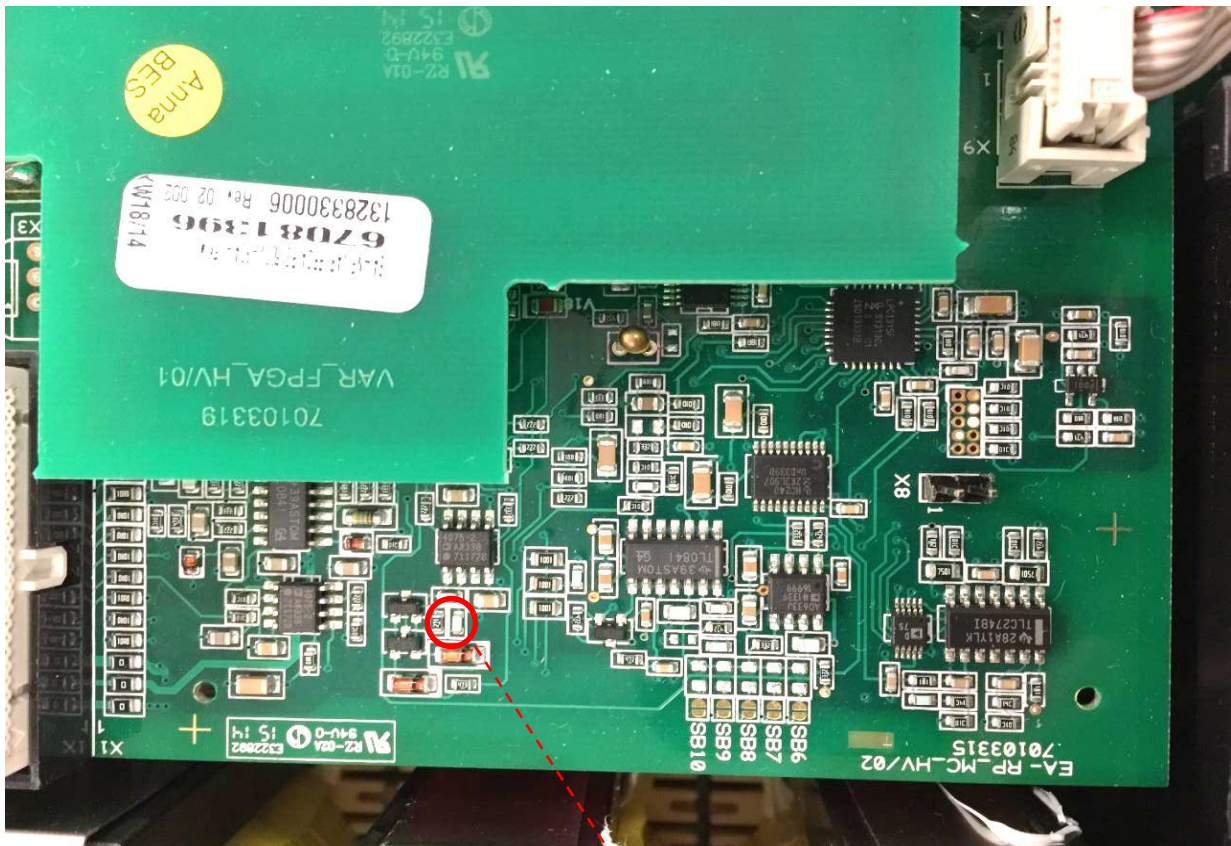
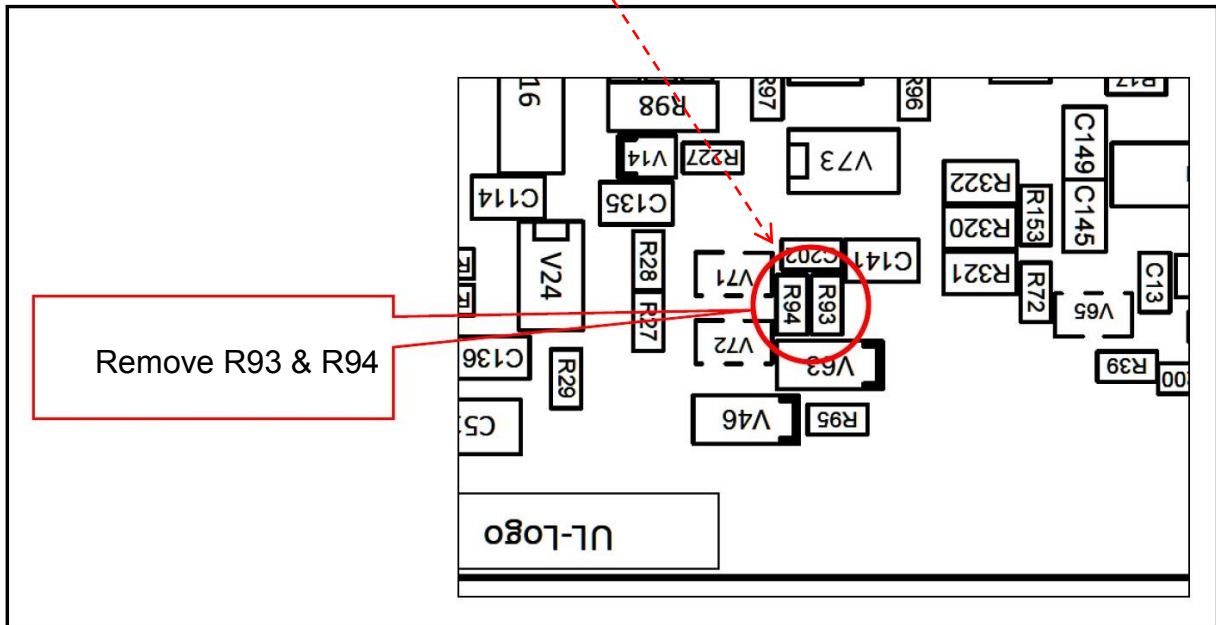
5) SMT resistors R93/94 are located in red circle shown below:

Removal of two (2) surface mount resistors, R93 and R94, will correct this problem:

6) After removal of R93 & R94, re-install all covers. Instrument does NOT require recalibration after the removal of R93 & R94.
