Modification Recommended Service Note

N8926A - Autoranging System DC Power Supply, 200V, 140A, 10000W, 208 VAC

Serial Numbers: DE14290000 - DE15369999 without manufacturing ID Version "B"

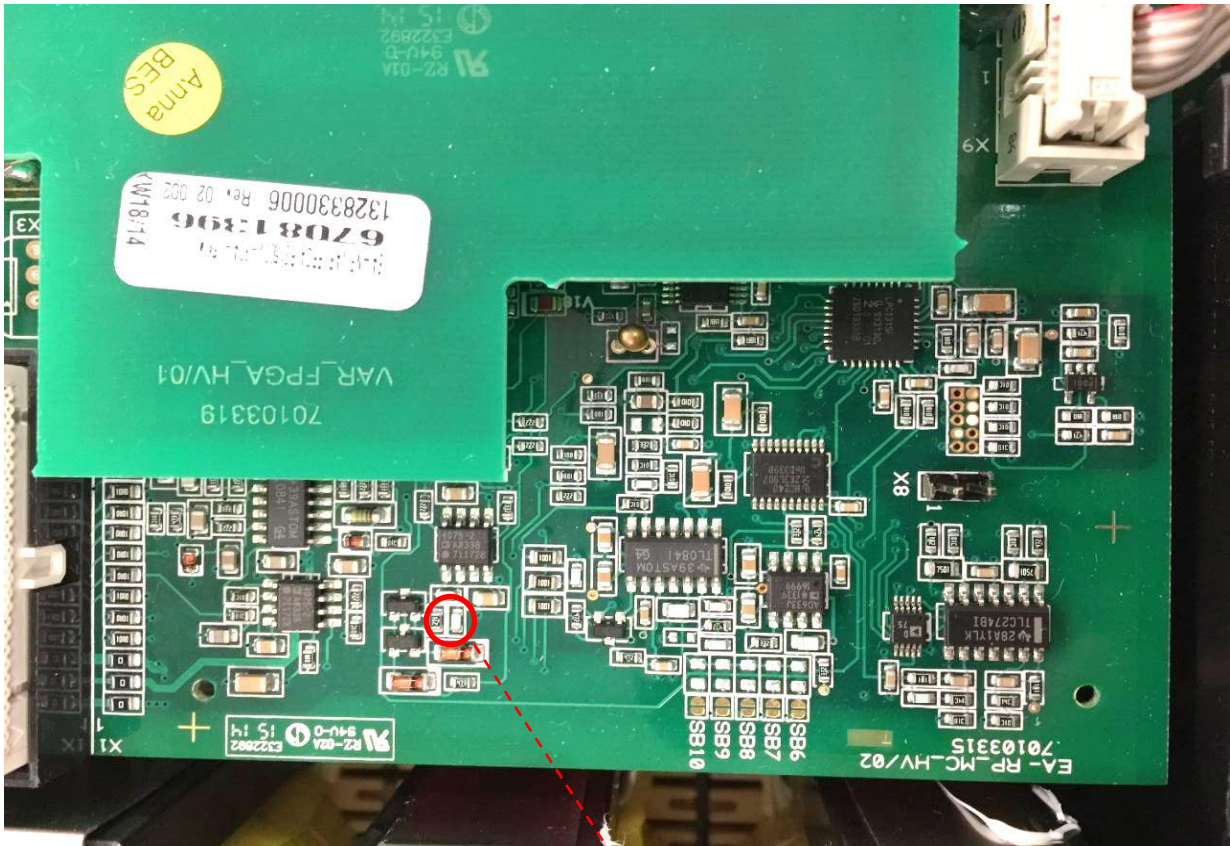
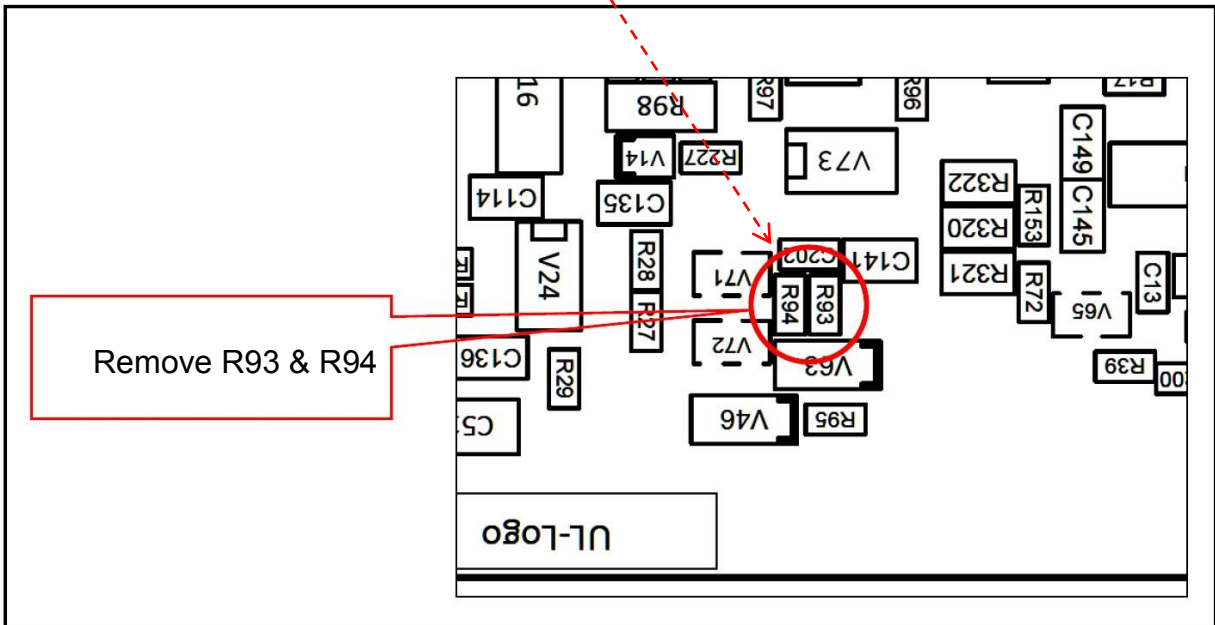
Operation of like model numbered products, in a Master/Slave current sharing configuration could result in a non-uniform distribution of the total output current amongst the configured units. Disparate current division may also cause individual instruments to oscillate.

5) SMT resistors R93/R94 are located in red circle shown below:

Removal of two (2) surface mount resistors, R93 and R94, will correct this problem:

6) After removal of R93 & R94, re-install all covers. Instrument does NOT require recalibration after the removal of R93 & R94.
