N8928A-01

Modification Recommended Service Note

N8928A - Autoranging System DC Power Supply, 500V, 60A, 10000W, 208 VAC

Serial Numbers: DE14290000 - DE15369999 without manufacturing ID Version "B"

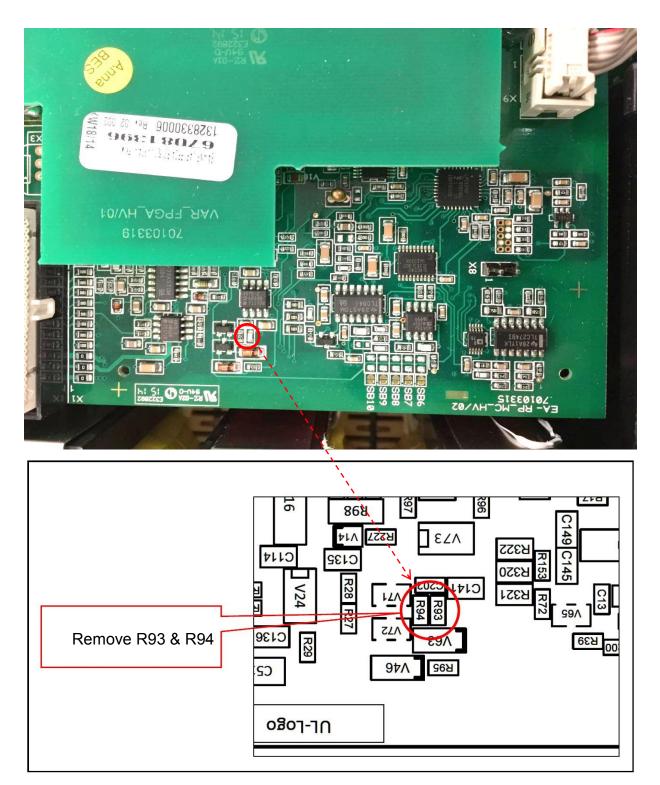
Operation of like model numbered products, in a Master/Slave current sharing configuration could result in a non-uniform distribution of the total output current amongst the configured units. Disparate current division may also cause individual instruments to oscillate.

5) SMT resistors R93/94 are located in red circle shown below:

Removal of two (2) surface mount resistors, R93 and R94, will correct this problem:

6) After removal of R93 & R94, re-install all covers. Instrument does NOT require recalibration after the removal of R93 & R94.
