N8930A-01

# Modification Recommended Service Note

## N8930A - Autoranging System DC Power Supply, 1000V, 30A, 10000W, 208 VAC

Serial Numbers: DE14290000 - DE15369999 without manufacturing ID Version "B"

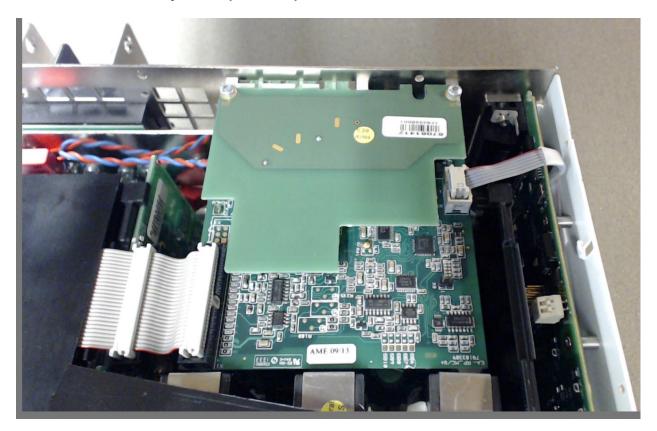
- 1) Remove acMains cable from power source.
- 2) Wait 5 minutes
- 3) Remove top cover from instrument.
- 4) In the 5kW units (viewed from the front of the unit), a small SMT assembly located at the right-rear of instrument will be readily visible (see below):

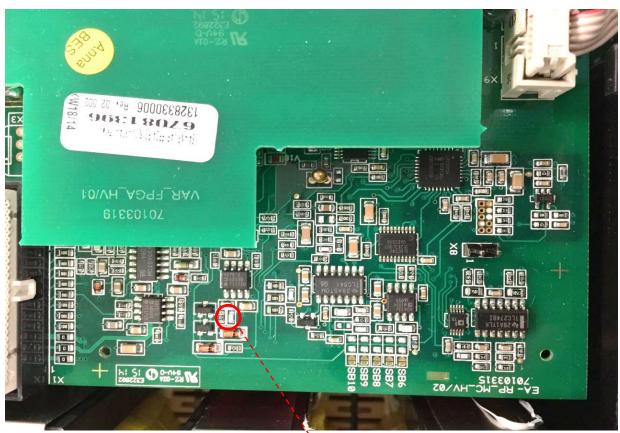
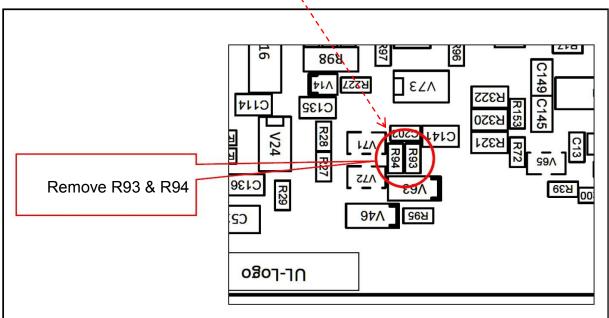
5) SMT resistors R93/94 are located in red circle shown below:

Removal of two (2) surface mount resistors, R93 and R94, will correct this problem:

6) After removal of R93 & R94, re-install all covers. Instrument does NOT require recalibration after the removal of R93 & R94.
