N8935A-01

Modification Recommended Service Note

N8935A - Autoranging System DC Power Supply, 750V, 60A, 15000W, 208 VAC

Serial Numbers: DE14290000 - DE15369999 without manufacturing ID Version "B"

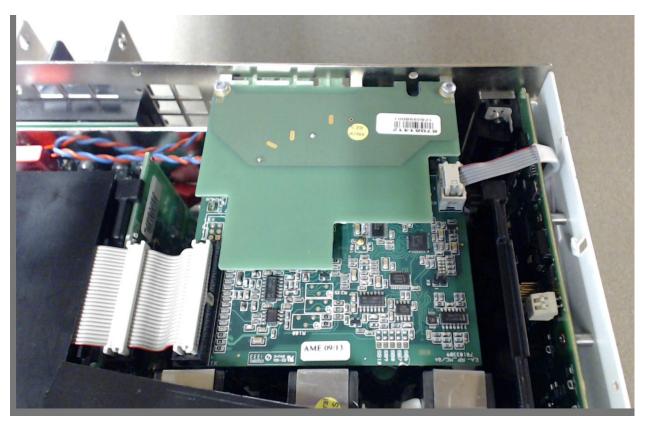
4) In the 5kW units (viewed from the front of the unit), a small SMT assembly located at the right-rear of instrument will be readily visible (see below):

In the 10kW & 15kW units; although found in the same location, a black plastic cover will have to be removed to gain visibility and access to the SMT assembly. Plastic cover snaps-on and can be removed with a small screwdriver.

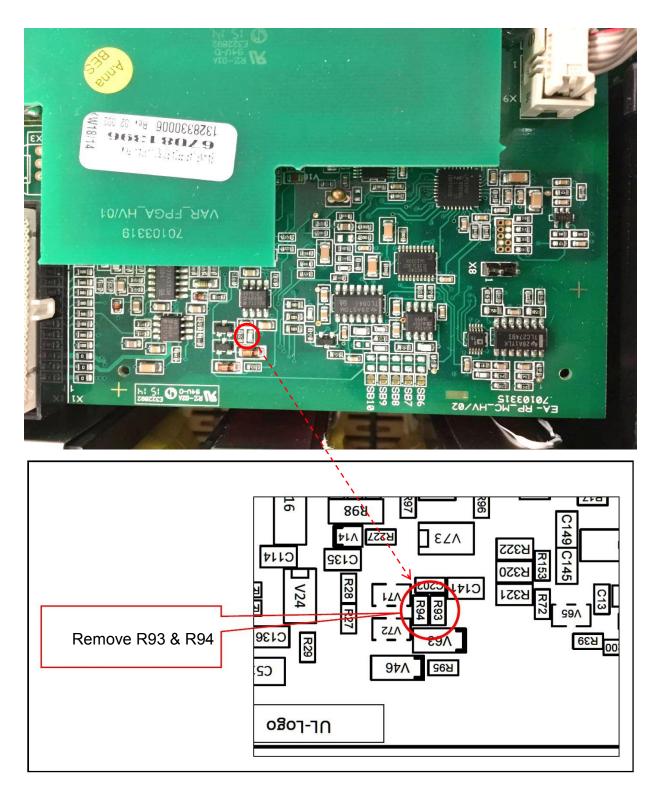
5) SMT resistors R93/94 are located in red circle shown below:

Removal of two (2) surface mount resistors, R93 and R94, will correct this problem:

6) After removal of R93 & R94, re-install all covers. Instrument does NOT require recalibration after the removal of R93 & R94.
