Modification Recommended Service Note

N8940A - Autoranging System DC Power Supply, 80V, 170A, 5000W, 400 VAC

Serial Numbers: DE14290000 - DE15369999 without manufacturing ID Version "B"

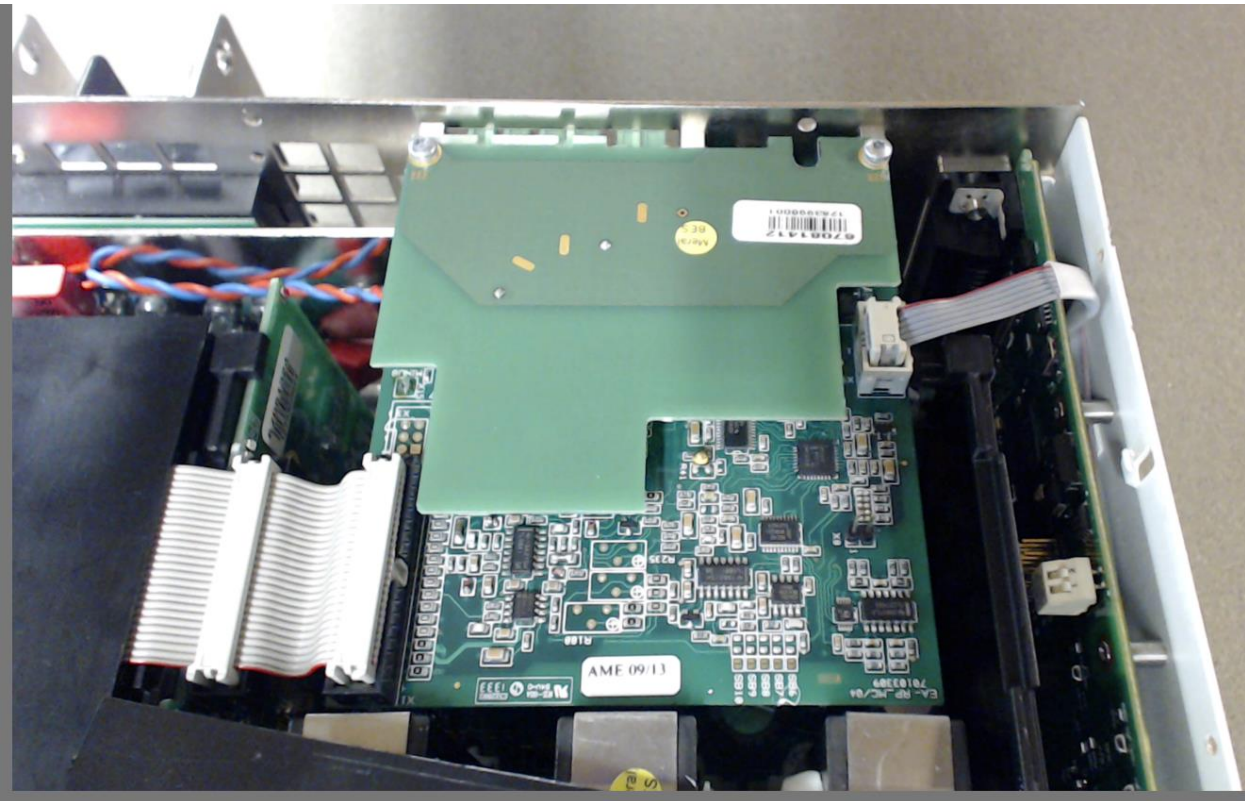
- 1) Remove acMains cable from power source.
- 2) Wait 5 minutes
- 3) Remove top cover from instrument.
- 4) In the 5kW units (viewed from the front of the unit), a small SMT assembly located at the right-rear of instrument will be readily visible (see below):

Removal of two (2) surface mount resistors, R93 and R94, will correct this problem:
