N8941A-01

Modification Recommended Service Note

N8941A - Autoranging System DC Power Supply, 200V, 70A, 5000W, 400 VAC

Serial Numbers: DE14290000 - DE15369999 without manufacturing ID Version "B"

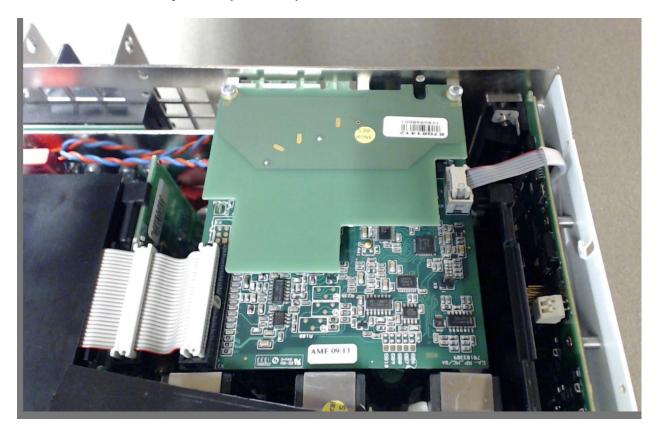
- 1) Remove acMains cable from power source.
- 2) Wait 5 minutes
- 3) Remove top cover from instrument.
- 4) In the 5kW units (viewed from the front of the unit), a small SMT assembly located at the right-rear of instrument will be readily visible (see below):

In the 10kW & 15kW units; although found in the same location, a black plastic cover will have to be removed to gain visibility and access to the SMT assembly. Plastic cover snaps-on and can be removed with a small screwdriver.

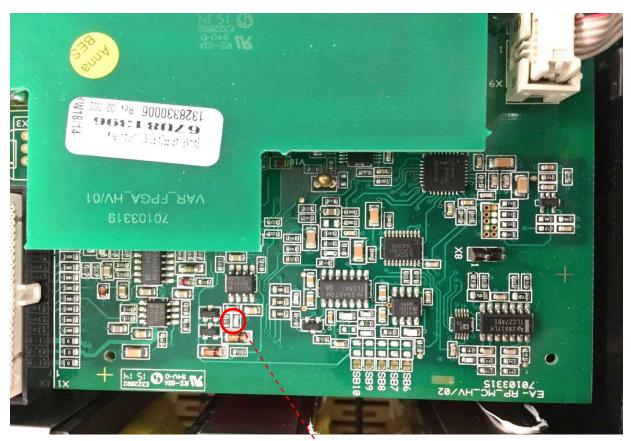
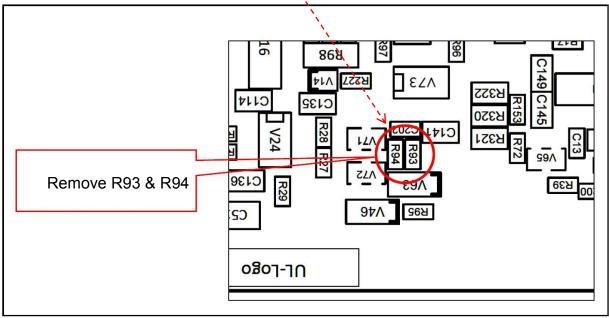
Resistors R93 and R94 must be removed, no replacement parts are required for modification.

5) SMT resistors R93/94 are located in red circle shown below:

Removal of two (2) surface mount resistors, R93 and R94, will correct this problem:

6) After removal of R93 & R94, re-install all covers. Instrument does NOT require recalibration after the removal of R93 & R94.
