N8950A-01

Modification Recommended Service Note

N8950A - Autoranging System DC Power Supply, 1000V, 30A, 10000W, 400 VAC

Serial Numbers: DE14290000 - DE15369999 without manufacturing ID Version "B"

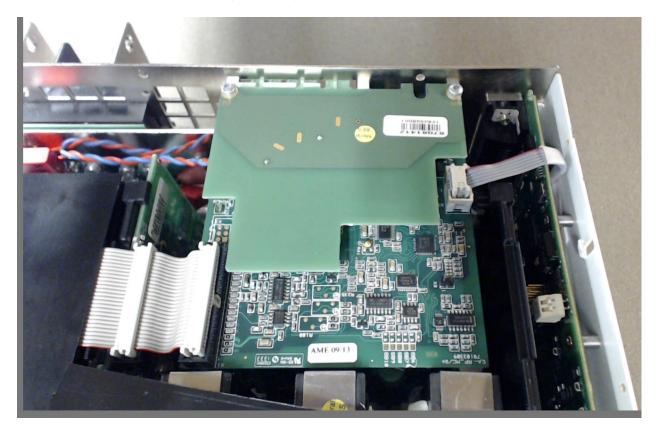
- 1) Remove acMains cable from power source.
- 2) Wait 5 minutes
- 3) Remove top cover from instrument.
- 4) In the 5kW units (viewed from the front of the unit), a small SMT assembly located at the right-rear of instrument will be readily visible (see below):

Removal of two (2) surface mount resistors, R93 and R94, will correct this problem:
