N9048B-02

Modification Recommended Service Note

N9048B PXE EMI Receiver

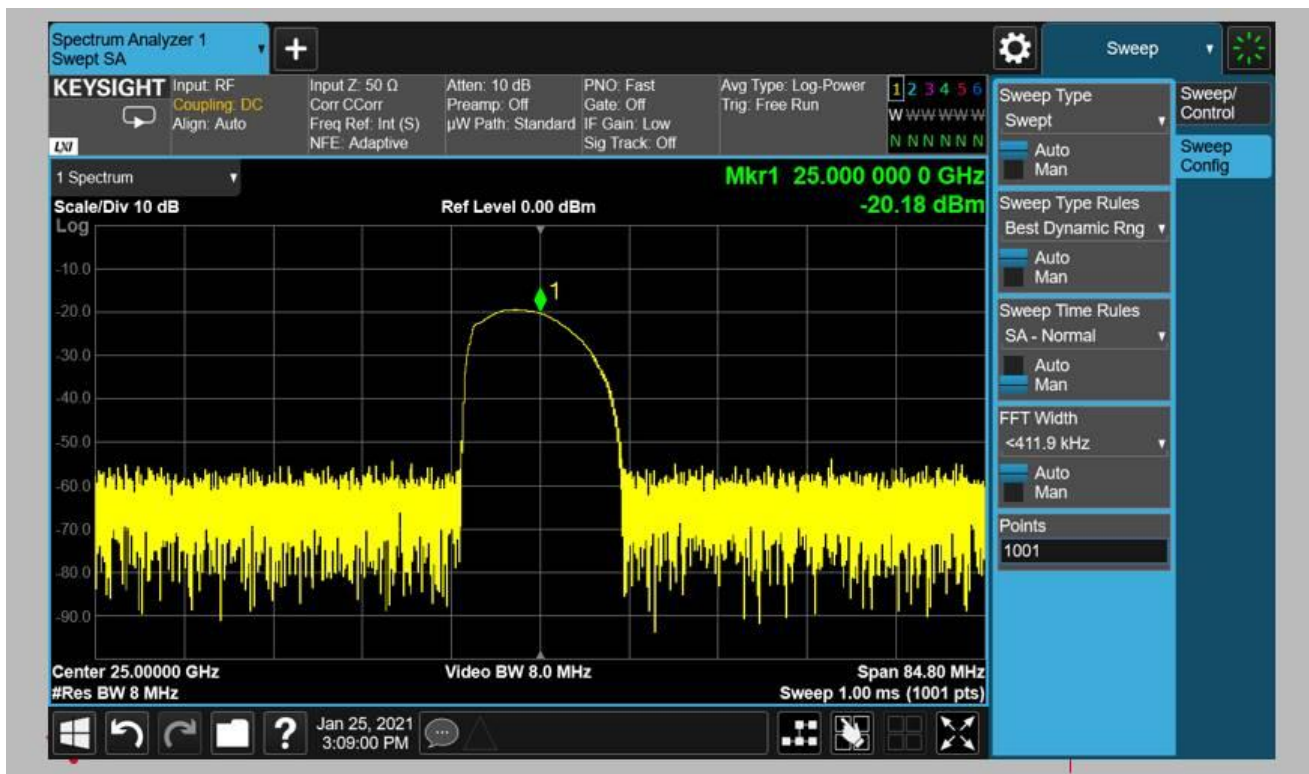
Calibration values on certain disk image versions causes the preselector filter used above 3.6 GHz to be swept too quickly and this will result in measured amplitude loss. The amount of loss will vary and depends on whether the Preselector Center routine was performed, the frequency span setting, and the Sweep Time Rules setting, where the default Sweep Time Rules setting is Normal, which allows faster sweeps than the Accuracy setting.

If you want to verify the problem, set up the analyzer as shown in this screen shot. A 25 GHz signal at -15 dBm is provided by a signal source. Notice the signal is distorted, and the amplitude is 5 dB lower than expected.

1. Download and install instrument software A.28.07 or later. This software version ignores the calibration values on the instrument disk image that cause the issue.
2. Perform the built-in Characterize Preselector routine.
Press **System** (the gear icon in the upper right portion of the instrument screen), **Alignments**, **Advanced**, **Characterize Preselector**.
