N9913A-02

S E R V I C E N O T E

N9913A FieldFox Handheld Analyzer

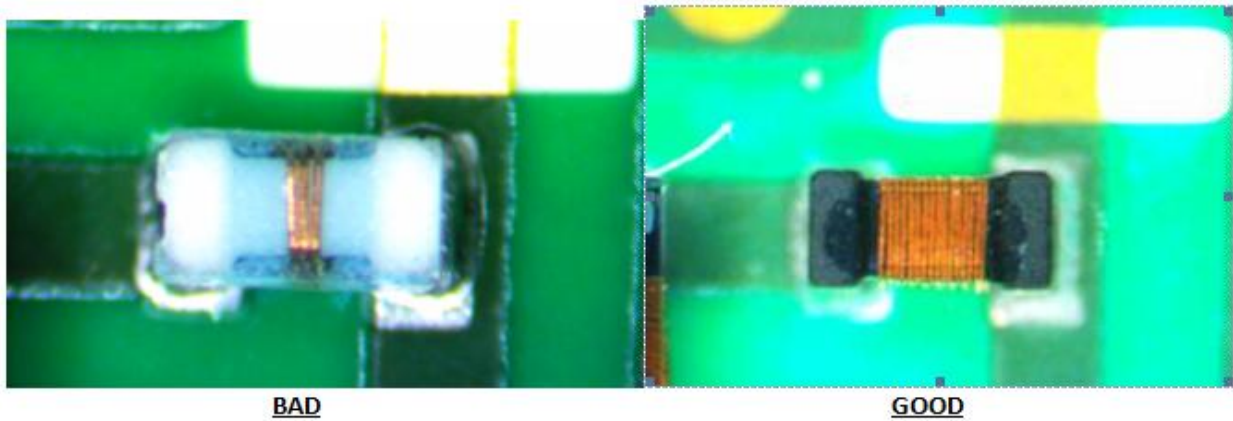
FieldFox instruments with the serial numbers listed below may show potential DANL failures with 3-4 dB difference due to misloaded inductor on the RF board. If DANL improvement is necessary, a new RF board is available to fix this it.

Figure 1: Image showing the good and bad inductor on location U678 at RF Board

Affected FieldFox with necessary DANL improvement are required to send back to Agilent factory for a new RF board replacement. Test and Adjustment shall be done before shipping back to customer.
