# N9914A-02 <u>S E R V I C E N O T E</u>

## N9914A FieldFox Handheld Analyzer

FieldFox instruments with the serial numbers listed on the following page may generate potential DANL failure due to different inductor being placed. A new RF board is required if DANL improvement is necessary.

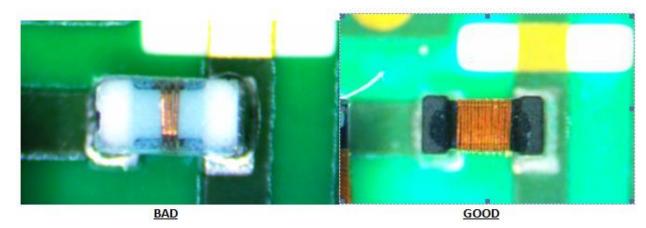
FieldFox instruments with the serial numbers listed below may show potential DANL failures with 3-4 dB difference due to misloaded inductor on the RF board. If DANL improvement is necessary, a new RF board is available to fix this it.

#### Figure 1: Image showing the good and bad inductor on location U678 at RF Board

Affected FieldFox with necessary DANL improvement are required to send back to Agilent factory for a new RF board replacement. Test and Adjustment shall be done before shipping back to customer.
