N9917A-02

S E R V I C E N O T E

N9917A FieldFox Handheld Analyzer

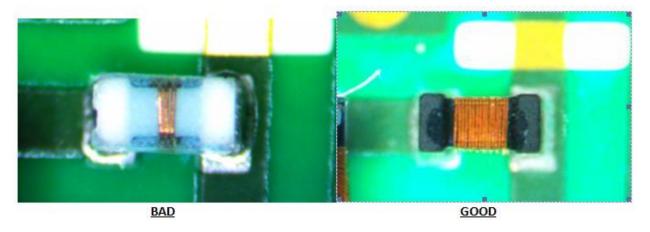
FieldFox instruments with the serial numbers listed below may show potential DANL failures with 3-4 dB difference due to misloaded inductor on the RF board. If DANL improvement is necessary, a new RF board is available to fix this it.

Figure 1: Image showing the good and bad inductor on location U678 at RF Board

Affected FieldFox with necessary DANL improvement are required to send back to Agilent factory for a new RF board replacement. Test and Adjustment shall be done before shipping back to customer.
