N9918A-02

S E R V I C E N O T E

N9918A FieldFox Handheld Analyzer

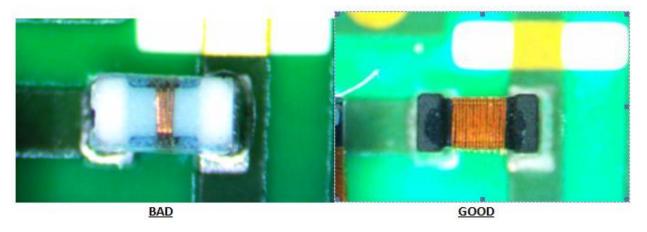
FieldFox instruments with the serial numbers listed below may show potential DANL failures with 3-4 dB difference due to misloaded inductor on the RF board. If DANL improvement is necessary, a new RF board is available to fix this it.

Figure 1: Image showing the good and bad inductor on location U678 at RF Board

Affected FieldFox with necessary DANL improvement are required to send back to Agilent factory for a new RF board replacement. Test and Adjustment shall be done before shipping back to customer.
