Modification Recommended Service Note

P5002A Keysight Streamline USB Vector Network Analyzer

Serial Numbers: From MY58100696 to MY58100732

Potential lifted front panel overlay

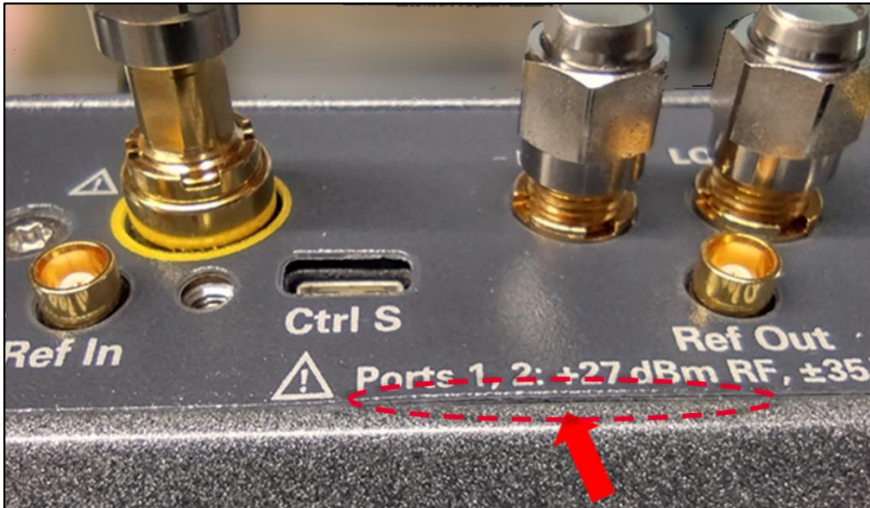
Keysight streamline series vector network analyzer (VNA) of serial number range identified in service note cover page might potentially exhibit the following lifted front panel overlay symptom.

Apart from cosmetic imperfections, the lifted front overlay could have led to non-fully attached *Ctrl S* micro-HDMI cable connector in multi-VNAs setup configuration.

-> Apply this service note only if end users' VNA is exhibiting the following symptom.

Procedure to replace the front panel overlay.

2. Pry open the existing front panel overlay and remove it from front panel.
3. Clean the metal surface thoroughly and ensure it is free of adhesive residue.
4. Affix the new self-adhesive front panel overlay onto the metal surface.
5. Reinstall (reuse) the 50-ohm terminations or protecting caps accordingly.

6. Reinstall (reuse) the front handles.
