Modification Recommended Service Note

P5002B Keysight Streamline Vector Network Analyzer

Serial Numbers: From MY61100009 to MY61100135

Potential lifted front panel overlay

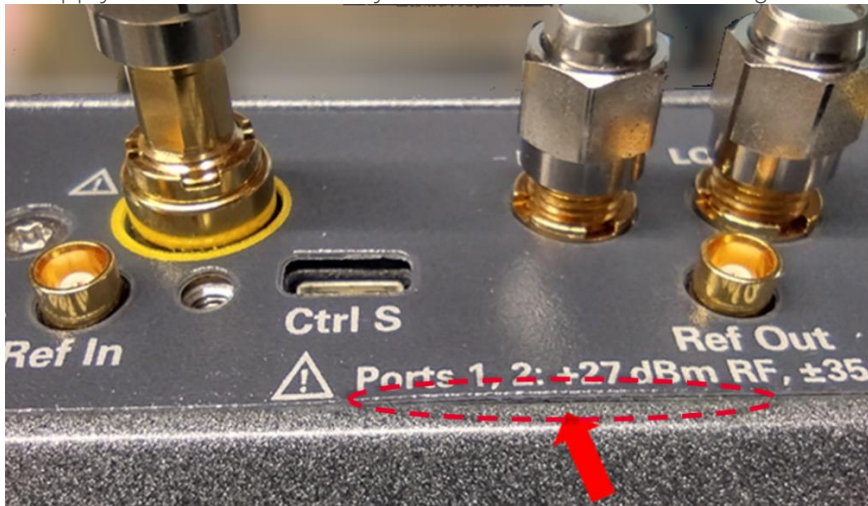
Keysight streamline series vector network analyzer (VNA) of serial number range identified in service note cover page might potentially exhibit the following lifted front panel overlay symptom.

Apart from cosmetic imperfections, the lifted front overlay could have led to non-fully attached *Ctrl S* micro-HDMI cable connector in multi-VNAs setup configuration.

-> Apply this service note only if end users' VNA is exhibiting the following symptom.

Procedure to replace the front panel overlay.

2. Pry open the existing front panel overlay and remove it from front panel.
3. Clean the metal surface thoroughly and ensure it is free of adhesive residue.
4. Affix the new self-adhesive front panel overlay onto the metal surface.
5. Reinstall (reuse) the 50-ohm terminations and port protecting caps accordingly.

6. Reinstall (reuse) the front handles.
