Modification Recommended Service Note

P5006A Keysight Streamline USB Vector Network Analyzer

Serial Numbers: From MY58100426 to MY58100451

Potential lifted front panel overlay

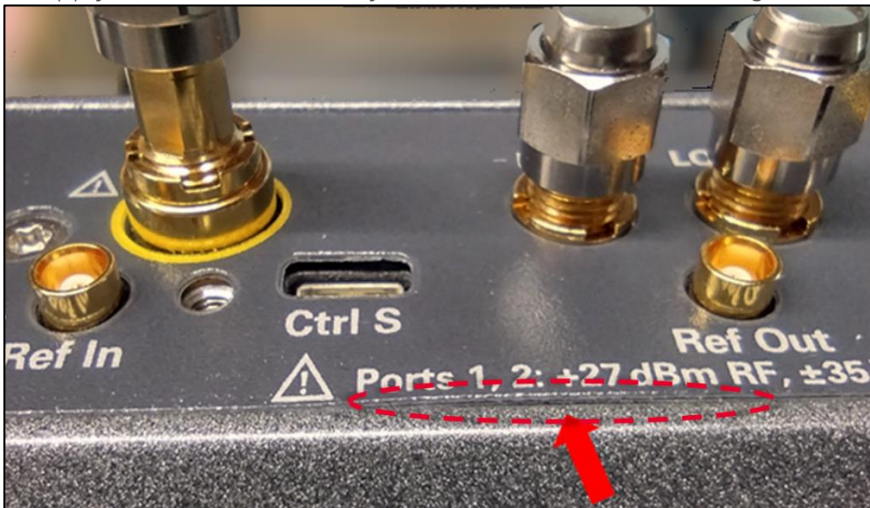
Keysight streamline series vector network analyzer (VNA) of serial number range identified in service note cover page might potentially exhibit the following lifted front panel overlay symptom.

Apart from cosmetic imperfections, the lifted front overlay could have led to non-fully attached *Ctrl S* micro-HDMI cable connector in multi-VNAs setup configuration.

-> Apply this service note only if end users' VNA is exhibiting the following symptom.

Procedure to replace the front panel overlay.

2. Pry open the existing front panel overlay and remove it from front panel.
3. Clean the metal surface thoroughly and ensure it is free of adhesive residue.
4. Affix the new self-adhesive front panel overlay onto the metal surface.
5. Reinstall (reuse) the 50-ohm terminations or protecting caps accordingly.

6. Reinstall (reuse) the front handles.
