P5020A-05A

Information Only Service Note

P5020A Keysight Streamline USB Vector Network Analyzer

Firmware update requirement to A.15.60.08 or newer for P5020A with MY582, SG582 serial prefix.

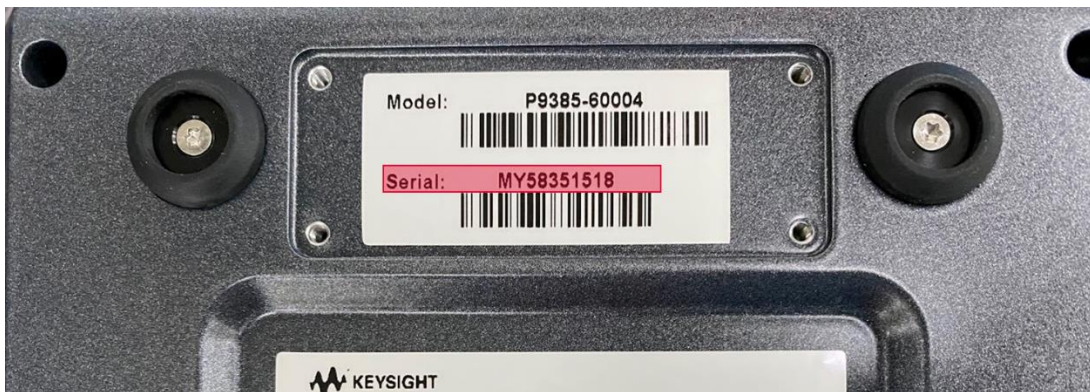
To identify the chassis generation, refer to the hardware serial number break as follows.
