P5021A-04

# Information Only Service Note

## P5021A Keysight Streamline USB Vector Network Analyzer

False alarm on self-test failure on firmware revision of A.13.40.02 - DDR3 memory removal

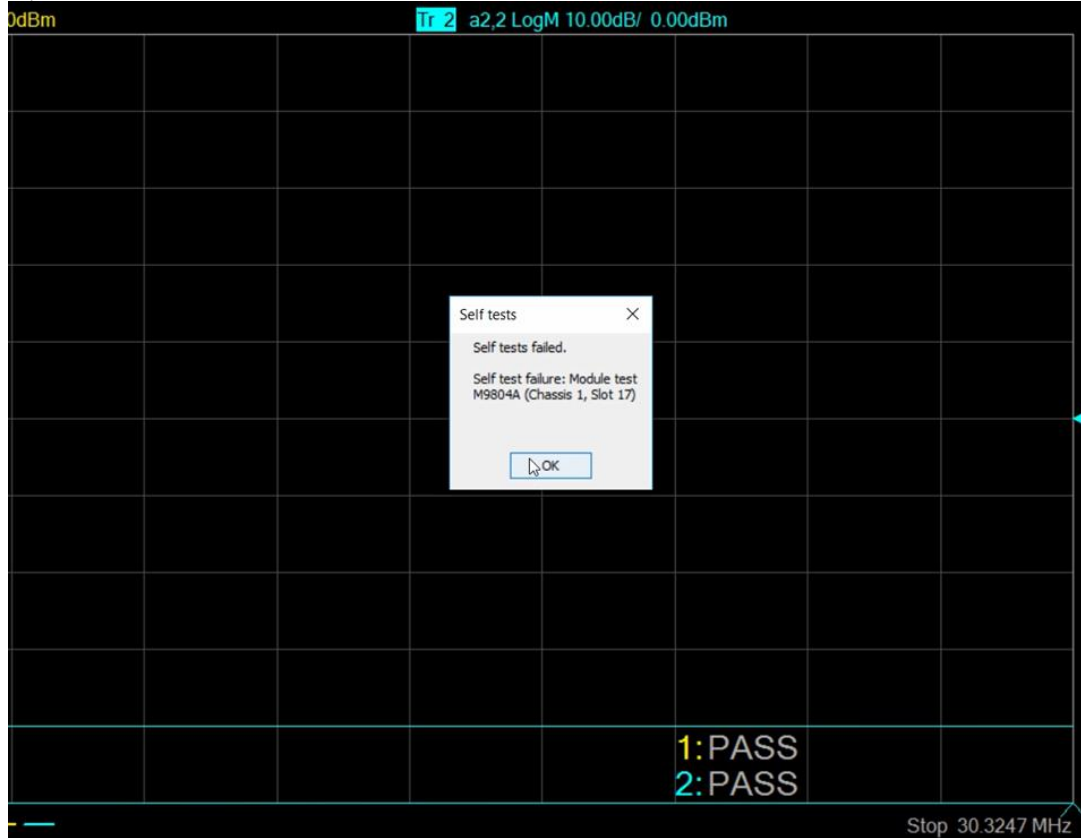
## Operator Check

Similarly, firmware will report a false failure in Operator check. Shown are the error messages example on VNA firmware UI.

Impacted firmware revision: A.13.40.02

For users with firmware revision of A.13.40.02,  
Update firmware to revision A.13.70.02 or newer to resolve this false alarm on self-test.
