P5023A-05

# Information Only Service Note

## P5023A Keysight Streamline USB Vector Network Analyzer

Firmware update requirement to A.15.60.08 or newer for P5023A with MY582, SG582 serial prefix.

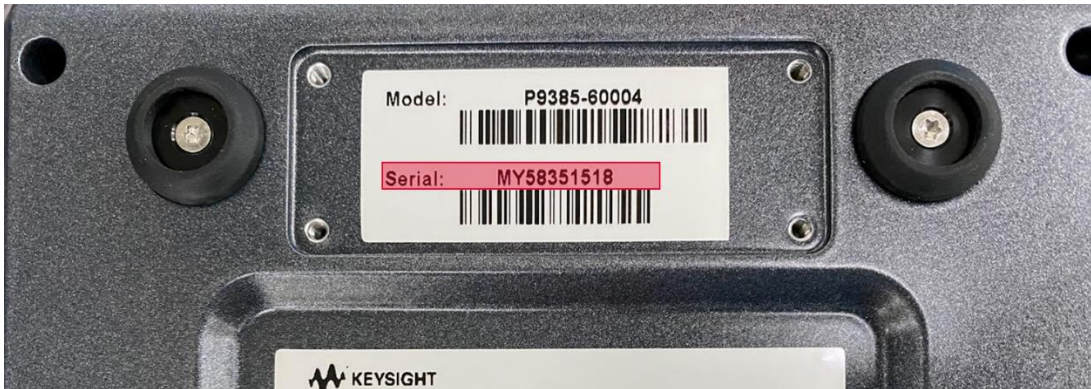
To identify the chassis generation, refer to the hardware serial number break as follows.

HW generation	Chassis Serial number
Old	MY58351xxx and below
New	MY58352xxx and above
