P5023A-05A

# Information Only Service Note

## P5023A Keysight Streamline USB Vector Network Analyzer

Firmware update requirement to A.15.60.08 or newer for P5023A with MY582, SG582 serial prefix.

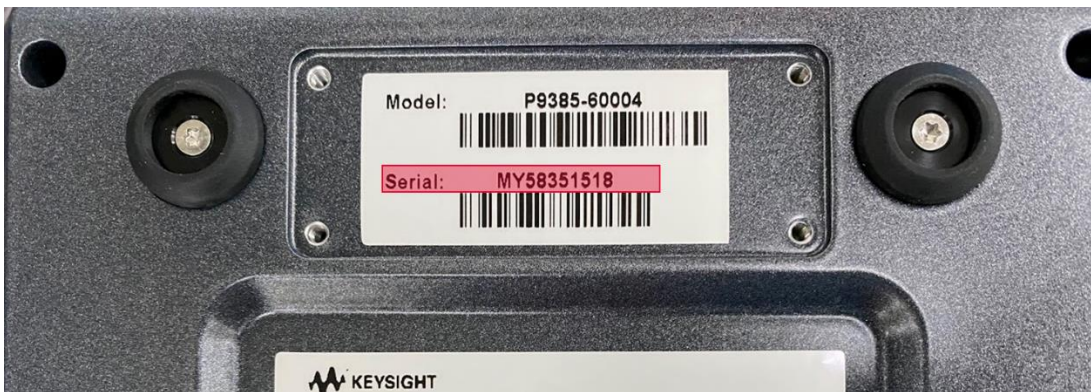
To identify the chassis generation, refer to the hardware serial number break as follows.

HW generation	Chassis Serial number
Old	MY58351xxx and below MY58353xxx and above
New	MY58352xxx

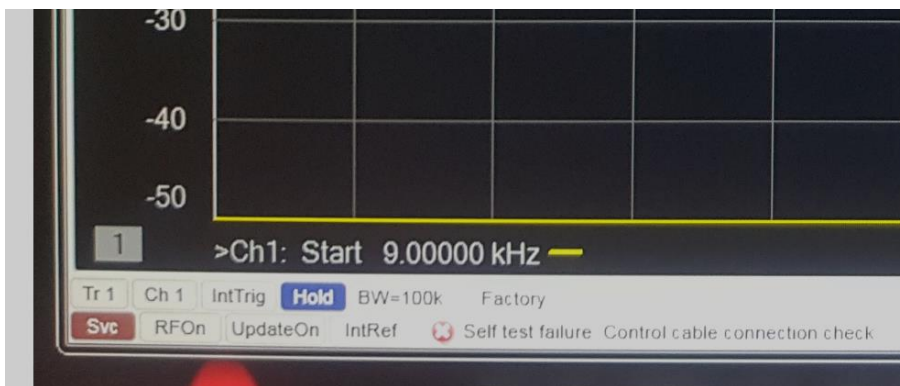
Listed are the known limitations if older firmware revision is used on the new chassis hardware.

1. 10MHz Ref-In (VNA front panel) fails to lock with external reference input signal.
2. On dual source VNA (P502xA option 402), firmware will prompt false alarm on self-test failure on cable connection check.

When the above symptom is discovered, update the user controller’s PC firmware revision to A.15.60.08 or newer.

If end user would like to retain the existing firmware revision, the work around is to update the IVI drivers manually.

1. Navigate to <http://www.keysight.com/find/P502xAMY582FWreq>
2. Download Ingot Chassis IVI-C Driver and save **KtPUsbChassis-IVI.NET-x64-1.1.8.0.msi** to Controller PC(s).
3. Download Ingot Chassis IVI.NET Driver & SFP and save **KtPUsbChassis-IVI-C-x64-1.1.8.0.msi** to Controller PC(s).
4. Install **KtPUsbChassis-IVI-C-x64-1.1.8.0.msi** followed with **KtPUsbChassis-IVI.NET-x64-1.1.8.0.msi** on user controller PC(s).
5. Restart both controller PC and VNA.
