P5024A-05

# Information Only Service Note

## P5024A Keysight Streamline USB Vector Network Analyzer

Firmware update requirement to A.15.60.08 or newer for P5024A with MY582, SG582 serial prefix.

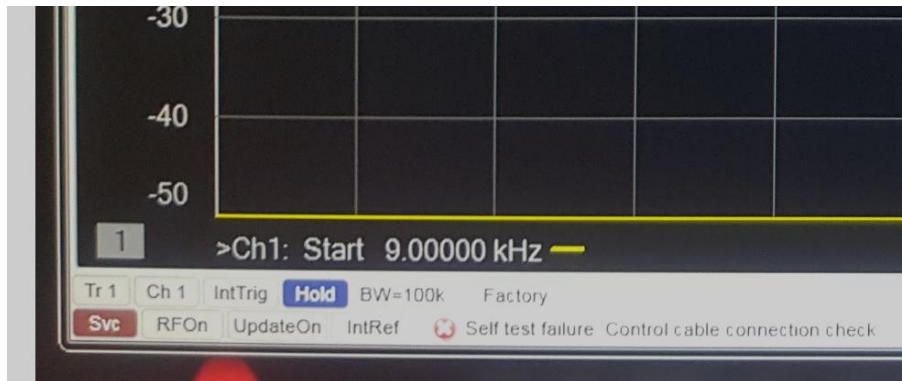
Listed are the known limitations if older firmware revision is used on the new chassis hardware.

1. 10MHz Ref-In (VNA front panel) fails to lock with external reference input signal.
2. On dual source VNA (P502xA option 402), firmware will prompt false alarm on self-test failure on cable connection check.

When the above symptom is discovered, update the user controller’s PC firmware revision to A.15.60.08 or newer.

If end user would like to retain the existing firmware revision, the work around is to update the IVI drivers manually.

1. Navigate to <http://www.keysight.com/find/P502xAMY582FWreq>
2. Download Ingot Chassis IVI-C Driver and save **KtPUsbChassis-IVI.NET-x64-1.1.8.0.msi** to Controller PC(s).
3. Download Ingot Chassis IVI.NET Driver & SFP and save **KtPUsbChassis-IVI-C-x64-1.1.8.0.msi** to Controller PC(s).
4. Install **KtPUsbChassis-IVI-C-x64-1.1.8.0.msi** followed with **KtPUsbChassis-IVI.NET-x64-1.1.8.0.msi** on user controller PC(s).
5. Restart both controller PC and VNA.
