P5027A-03B-S

P5027A Keysight Streamline USB Vector Network Analyzer

Safety Service Note

"POTENTIAL BURN INJURY (HIGH TEMPERATURE) HAZARD" WARNING HAZARD CLASS 2

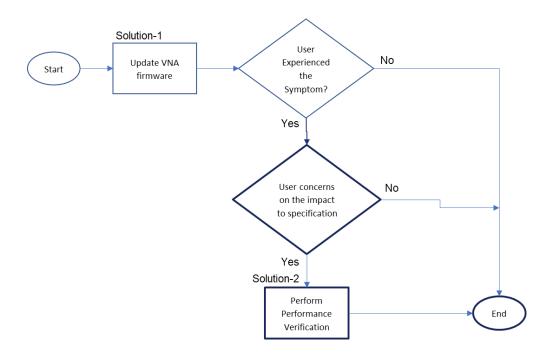
VNA fails to start with the following symptoms.

- 1. LED indicator (below circle) turns red.
- 2. cooling fan does not work

3. If user leaves the VNA with this LED indicator red without turning off power switch, it continues to overheat and becomes too hot.

Solution: Solution-1: Update VNA firmware by user

Solution-2: Perform Performance Verification by Keysight
