P5028A-05

# Information Only Service Note

## P5028A Keysight Streamline USB Vector Network Analyzer

Firmware update requirement to A.15.60.08 or newer for P5028A with MY582, SG582 serial prefix.

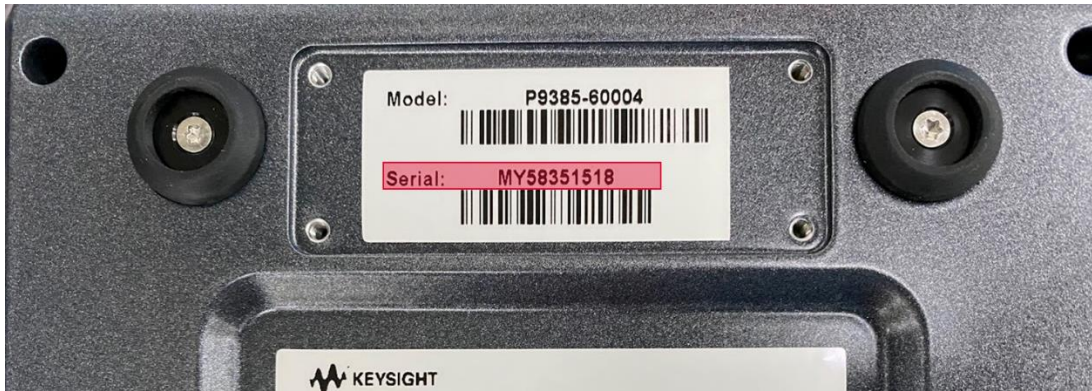
To identify the chassis generation, refer to the hardware serial number break as follows.

HW generation	Chassis Serial number
Old	MY58351xxx and below
New	MY58352xxx and above

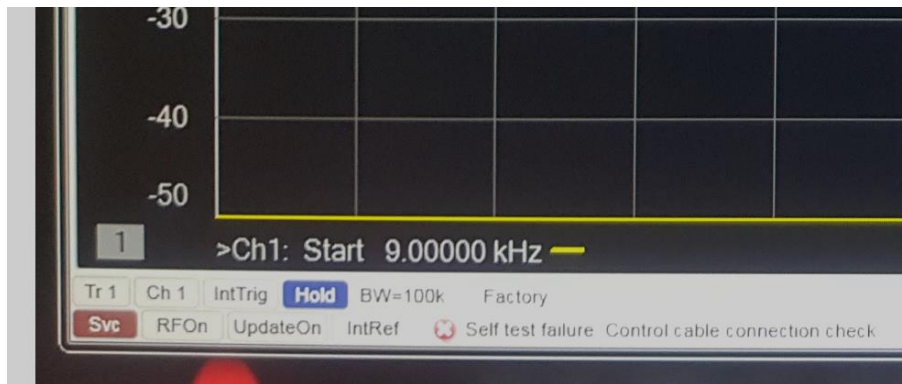
Listed are the known limitations if older firmware revision is used on the new chassis hardware.

- 1. 10MHz Ref-In (VNA front panel) fails to lock with external reference input signal.
- 2. On dual source VNA (P502xA option 402), firmware will prompt false alarm on self-test failure on cable connection check.

When the above symptom is discovered, update the user controller’s PC firmware revision to A.15.60.08 or newer.

If end user would like to retain the existing firmware revision, the work around is to update the IVI drivers manually.

1. Navigate to <http://www.keysight.com/find/P502xAMY582FWreq>
2. Download Ingot Chassis IVI-C Driver and save **KtPUsbChassis-IVI.NET-x64-1.1.8.0.msi** to Controller PC(s).
3. Download Ingot Chassis IVI.NET Driver & SFP and save **KtPUsbChassis-IVI-C-x64-1.1.8.0.msi** to Controller PC(s).
4. Install **KtPUsbChassis-IVI-C-x64-1.1.8.0.msi** followed with **KtPUsbChassis-IVI.NET-x64-1.1.8.0.msi** on user controller PC(s).
5. Restart both controller PC and VNA.
