P5028A-05A

Information Only Service Note

P5028A Keysight Streamline USB Vector Network Analyzer

Firmware update requirement to A.15.60.08 or newer for P5028A with MY582, SG582 serial prefix.

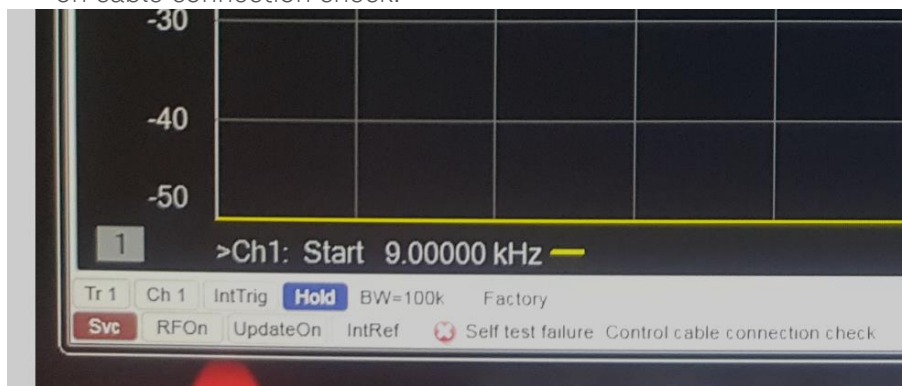
Listed are the known limitations if older firmware revision is used on the new chassis hardware.

1. 10MHz Ref-In (VNA front panel) fails to lock with external reference input signal.
2. On dual source VNA (P502xA option 402), firmware will prompt false alarm on self-test failure on cable connection check.

When the above symptom is discovered, update the user controller’s PC firmware revision to A.15.60.08 or newer.
