P9370A-03

Information Only Service Note

P9370A Vector Network Analyzer, 300 kHz to 4.5 GHz, 2-port

Firmware update requirement to A.15.75.22 or newer for P9370A with MY573, SG573 serial prefix.

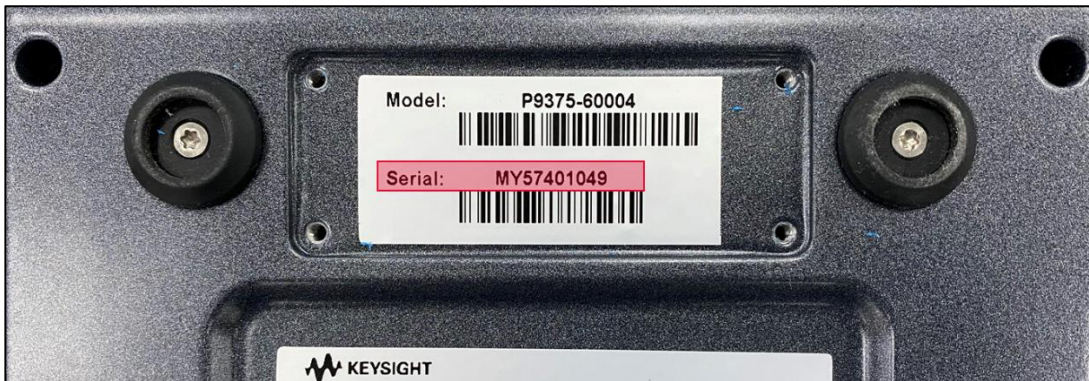
For repaired P937xA, to identify the chassis generation, refer to the hardware serial number break as follows. Shown below is an example of MY574 HW serial number with old chassis HW.

HW generation	Chassis Serial number
Old	MY574xxxxx
New	MY575xxxxx
