P9374A-03

# Information Only Service Note

## P9374A Vector Network Analyzer, 300 kHz to 20 GHz, 2-port

Firmware update requirement to A.15.75.22 or newer for P9374A with MY573, SG573 serial prefix.

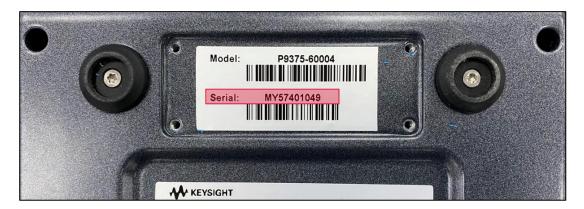
For repaired P937xA, to identify the chassis generation, refer to the hardware serial number break as follows. Shown below is an example of MY574 HW serial number with old chassis HW.

HW generation	Chassis Serial number
Old	MY57 <mark>4</mark> xxxxx
New	MY57 <mark>5</mark> xxxxx
