MODIFICATION RECOMMENDED –
CORRECTS MANUFACTURING OR DESIGN DEFECTS

SJ50-04

Agilent SJ50 Series II Optical Board Test System

Cable Stress On Rear Hood Hinge

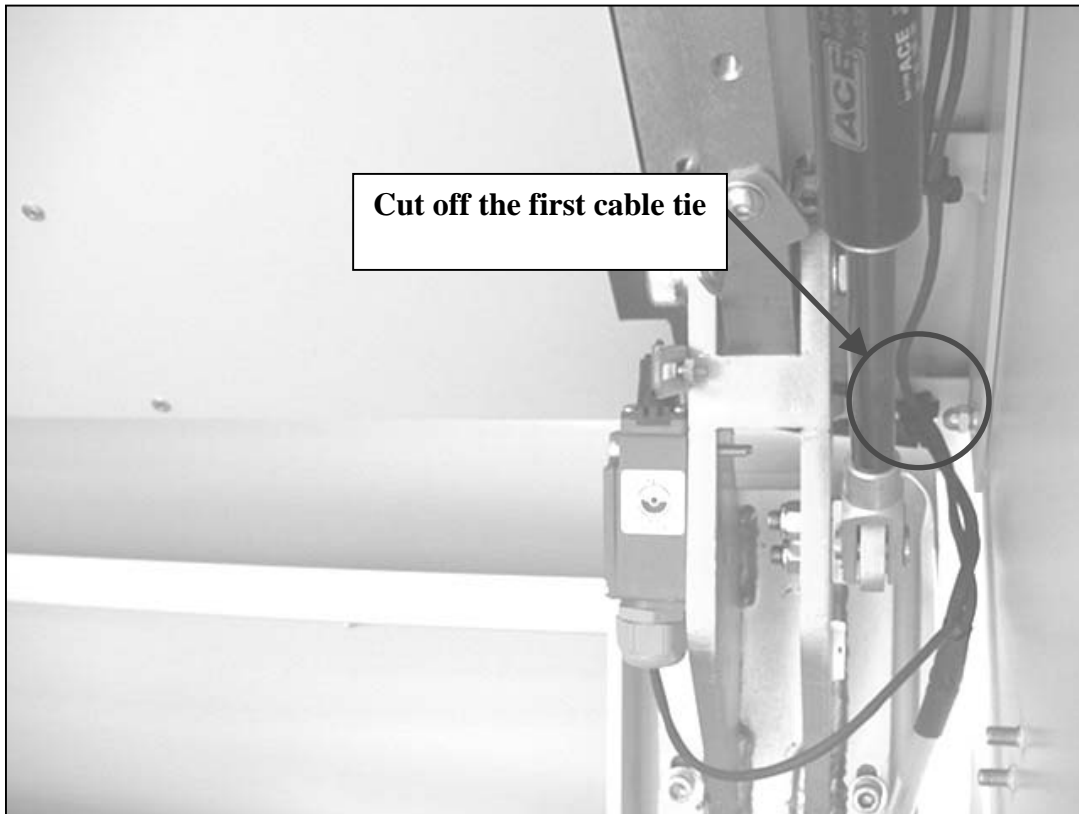
Figure 1

A cable on the SJ50 Series II System is being overly stressed when the Hood Assembly is opened and closed.

1. Cut off the cable tie on the first cable tie cleat.
The position is shown in **Figure 1**.
