Modification Recommended Service Note

T1250A-04

T1250A Smart RF Switching Unit

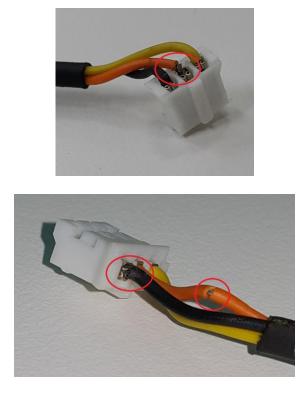
Failure analysis revealed a quality issue with the original control cables and DC power cables, as shown in the pictures below:

Cables crimping poor quality was the identified root cause.

Cable vendor was changed to ensure cables meet the quality standards (part numbers remained the same). The following picture shows an example of original cable, and new cable:

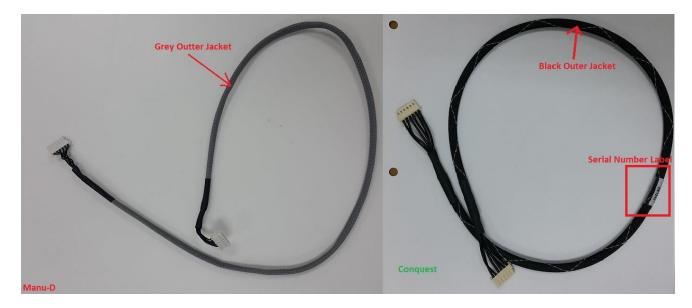
Original Manu-D cable vs new Conquest cable

• New units: this cable vendor change was implemented in Production starting with serial number MY54050143.

Installed base: any T1250A returned to Factory for service (this model is supported Return to Factory) since October 2015 has been reworked to replace the original control and DC cables with new vendor cables.
