U2002A-03

S E R V I C E N O T E

U2002A 50MHz – 24GHz USB Sensor

Difficulty to attach USB power sensor cable to power sensor unit.

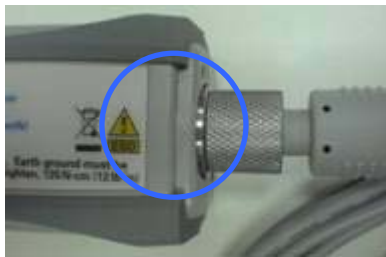
Figure 1: USB power sensor cable fully attached to power sensor unit

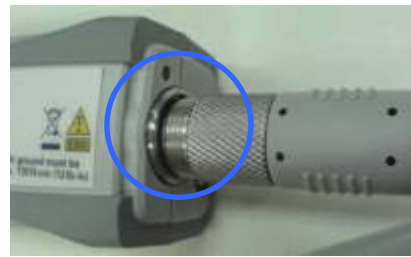
When the USB power sensor cable is attached to the power sensor unit, user may find it difficult to attach the cable to the power sensor unit.

Figure 2: USB power sensor cable not fully attached to power sensor unit

If user faces difficulty to attach the cable to the power sensor unit, kindly contact Agilent for free of charge cable replacement. Kindly scrap the used cable.
