# U2004A-03

# S E R V I C E N O T E

## U2004A 9kHz – 6GHz USB Sensor

**Difficulty to attach USB power sensor cable to power sensor unit.**

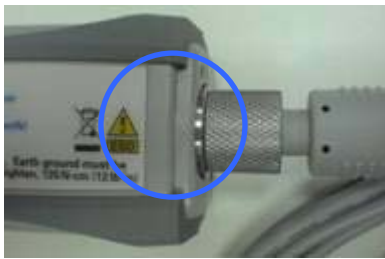
Figure 1: USB power sensor cable fully attached to power sensor unit

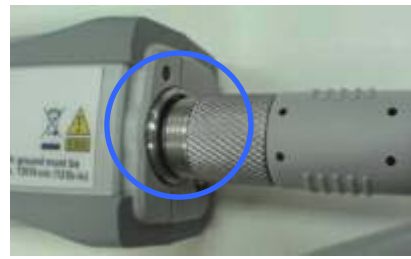
When the USB power sensor cable is attached to the power sensor unit, user may find it difficult to attach the cable to the power sensor unit.

Figure 2: USB power sensor cable not fully attached to power sensor unit

If user faces difficulty to attach the cable to the power sensor unit, kindly contact Agilent for free of charge cable replacement. Kindly scrap the used cable.
