Modification Recommended Service Note

U7179A 16-Channel High Current Load Card up to 15A

Serial Numbers: MY58120772 to MY58121103

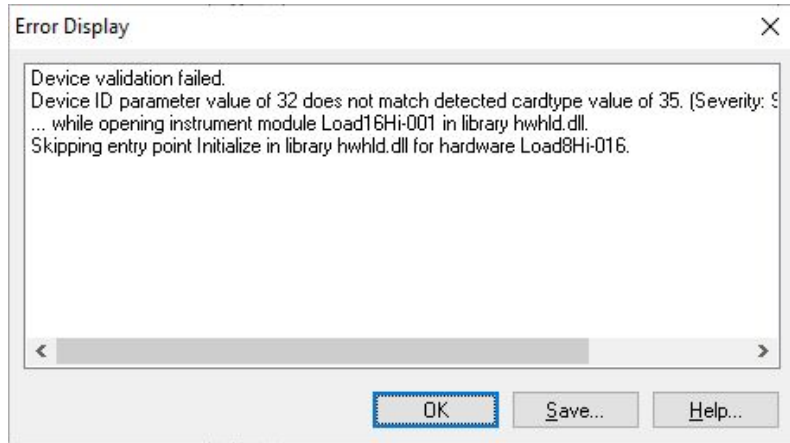
If all load cards are populated in the E6198B SLU (see screenshot), the hardware ID of the U7179A load card in the left-most slot (slots 1 or 3) is not recognized correctly. The correct ID for U7179A card is 32, while the invalid IDs that have been observed could be 33, 35, 36, 37, 38, 39, 40, 41, 44, 46, and 47 (not fixed).

When the U7179A load card is identified within the affected serial number range, replace the U7179A load card with U7179-81000. Otherwise, assume that the U7179A load card has no timing issue and do not proceed with this Service Note.

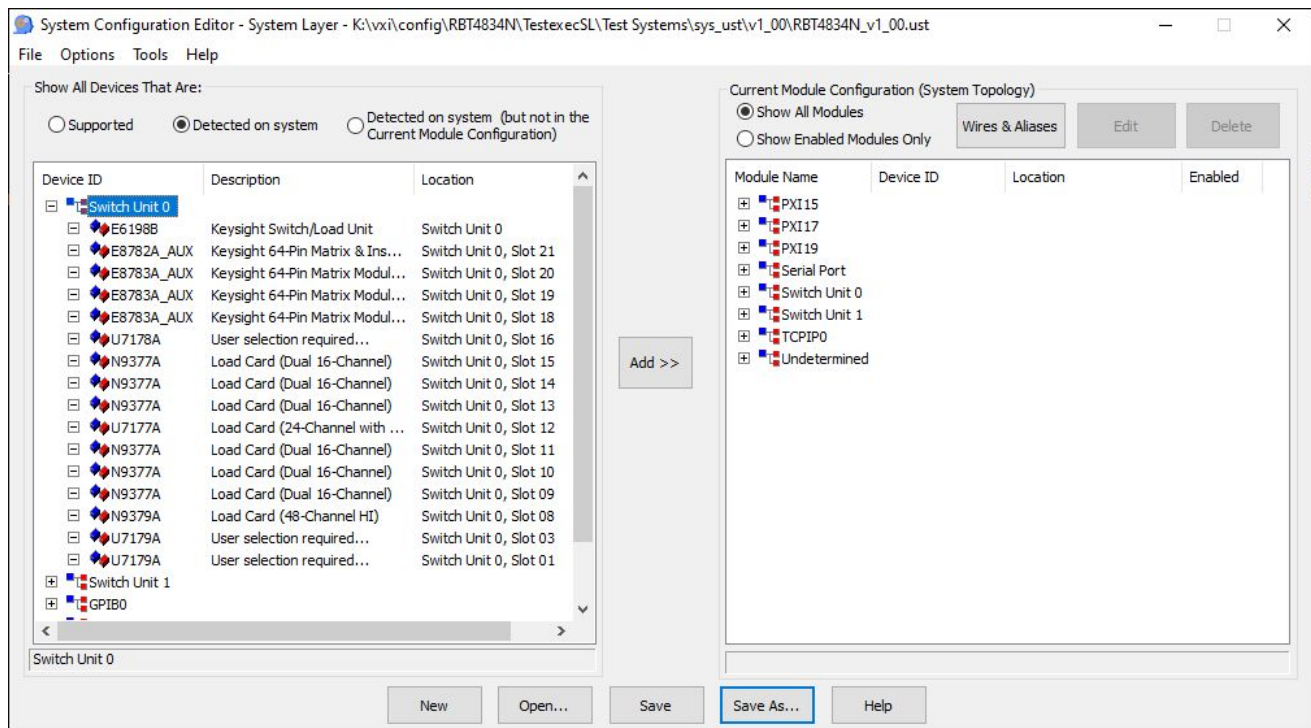
i.e. TestExec gives the following error message when it starts:

Hardware ID detection error only occurred if there are 10 or more cards in the SLU and happened at the left-most slot of the U7179A card. It is determined that delay in control signals that are fed to the ID IC will result in different U7179A ID. This delay causes the time mismatch on the timing diagram thus affecting U7179A ID signals.
