U8903A-01 S ERVICE

U8903A Audio Analyzer

Serial Numbers: MY49000000 - MY50439999

EMI shield soldering improvement

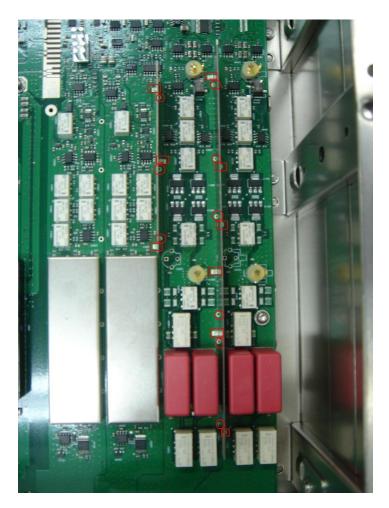
Improve the EMI shield plate soldering quality.

1. Situation 1 – EMI shield plate loose and moveable

2. <u>Situation 2 – EMI shield plate fallout from PCBA</u>

- ii. Check if EMI shield plate is loose or moveable.
- iii. Apply solder to the soldering pad (location as shown at red square box).
- iv. Clean the surrounding soldering area to avoid any solder shorts.

- i. Follow the service guide to remove the board.
- ii. Apply solder to the thru holes and soldering pad.
- iii. Clean the surrounding soldering area to avoid any solder shorts.
- iv. Perform calibration.
