Information Only Service Note

U9405A – i1000 Small Foot Print Inline systems

The Problem – Top rail bumper block(U9405-30302) causing delays on conveyor movements.

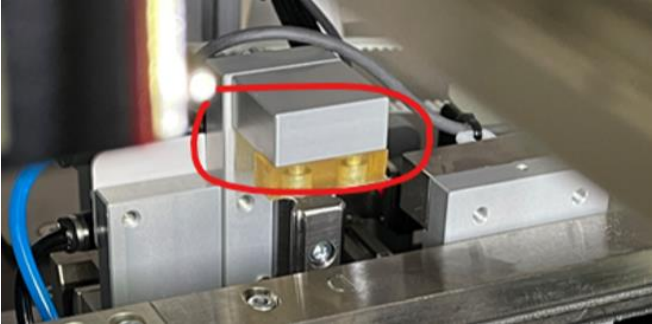
The cause of the problem is the smooth surface of the top rail bumper block(U9405-30302).

When the conveyor is at the UP position waiting for boards, the cylinder constantly pushes the rail up against the bumper block. If this continues for extended periods of time, the bumper block starts to stick to the conveyor rail. When the next board arrives and conveyor tries to move downwards, the stickiness will delay the movement as it takes slightly longer for the air pressure to break free from the bumper block. This causes the unsynchronized movement and result is dropping of boards from the conveyor.
