Information Only Service Note

U9405B – Keysight FlexiCore Parallel Test System

The Problem – Top rail bumper block(U9405-30302) causing delays on conveyor movements.

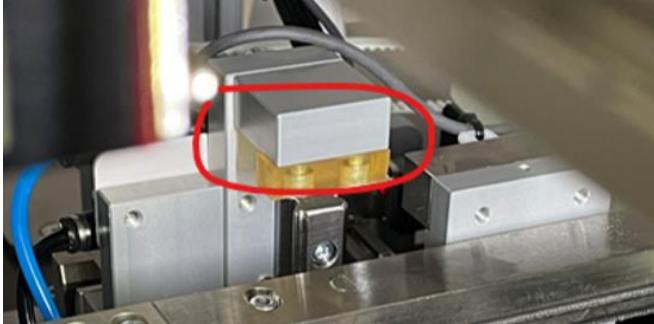
The cause of the problem is the smooth surface of the top rail bumper block(U9405-30302).

When the conveyor is at the UP position waiting for boards, the cylinder constantly pushes the rail up against the bumper block. If this continues for extended periods of time, the bumper block starts to stick to the conveyor rail. When the next board arrives and conveyor tries to move downwards, the stickiness will delay the movement as it takes slightly longer for the air pressure to break free from the bumper block. This causes the unsynchronized movement and result is dropping of boards from the conveyor.

The top rail bumper block(U9405-30302) will be processed to roughen up the surface which meets the conveyor rail. This eliminates the possibility of the conveyor rail sticking to the bumper block regardless of batch variances.
