**x6000-05-S**

# **S E R V I C E N O T E**

## Medalist x6000 Systems

### POSSIBLE X-ray Emission HAZARD

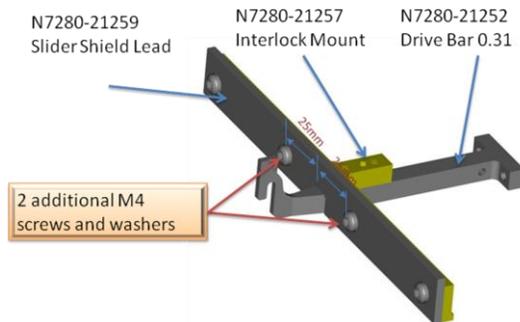
Picture of replacement part N7280-88786:

Using the replacement part N7280-88786 (inner barrier replacement kit, qty 1) will be required to update the inner barrier drive bar. Please return the used part for refurbishing.
